## **Remedial Detailed Site Investigation**

### **Wedge and Grey Shack Settlements**

Department of Parks and Wildlife

18 May 2017

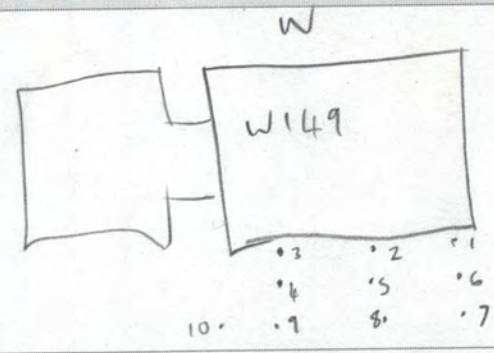
N → replaced for 130 Steel roof, ACM walls.

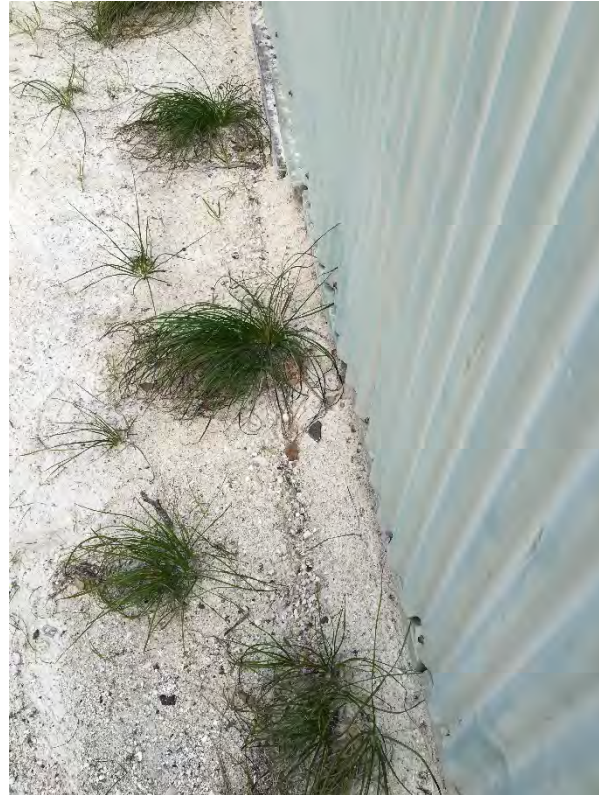
**Photo 3. Wedge shack W170, water run off drip line visible in sand where AF samples were collected.**

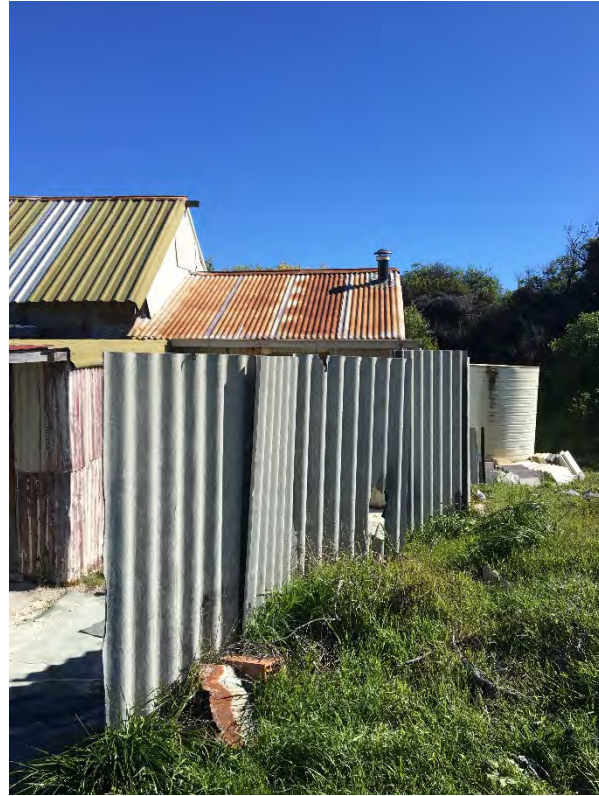
**Photo 5. Suspect ACM fence adjacent to Wedge shack W245, where AF sampling was conducted.**

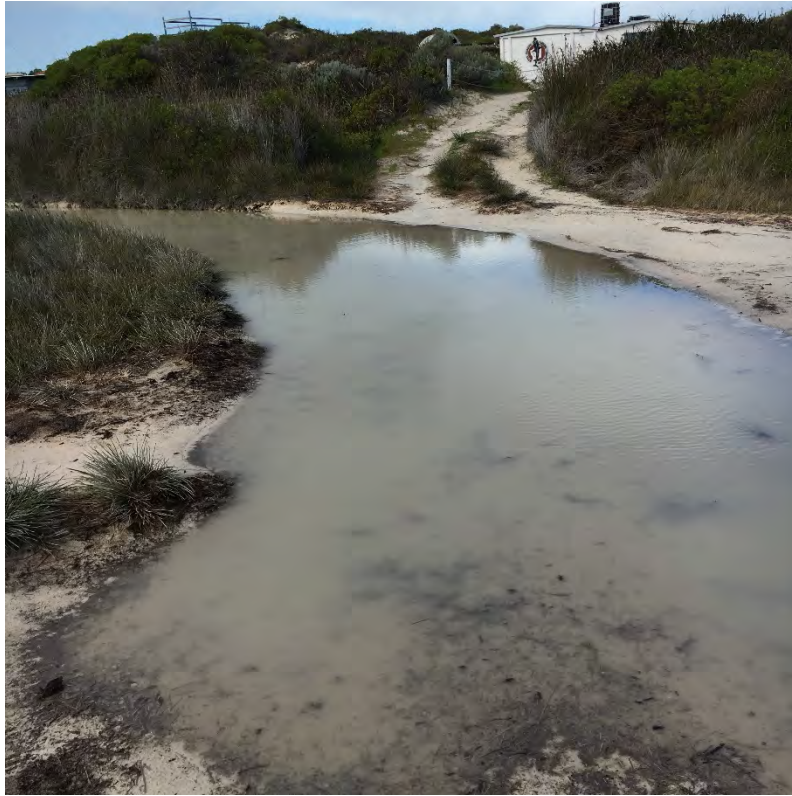
**Photo 7. Flooding of tracks at the commencement of the program at Wedge.**

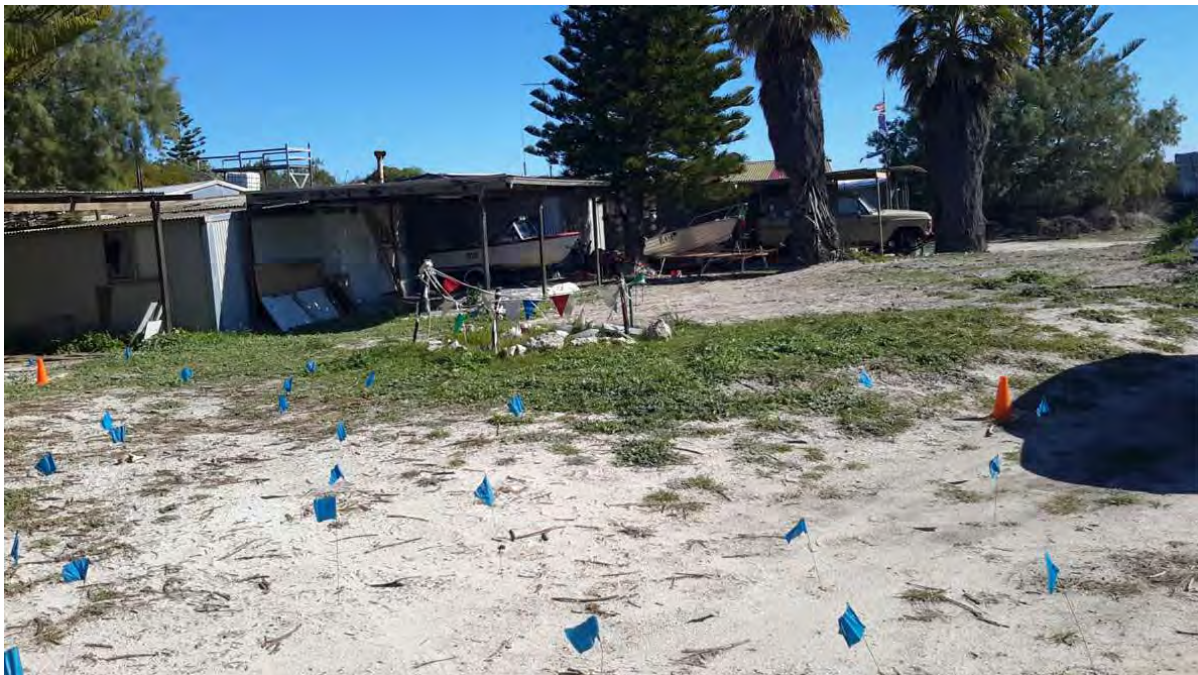
**Photo 8. Track and common area between W17 and W22 classified as 'outstanding' due to large amount of scattered suspect ACM fragments.**

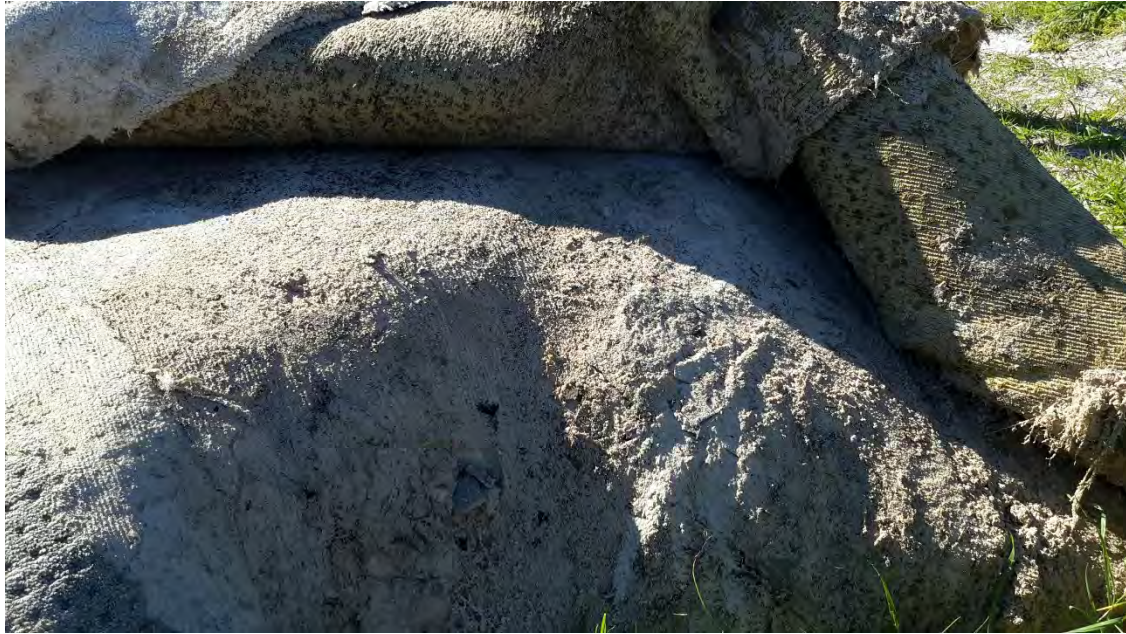
**Photo 11. Typical mound of material with suspect ACM buried throughout. This mound is east of W14.**

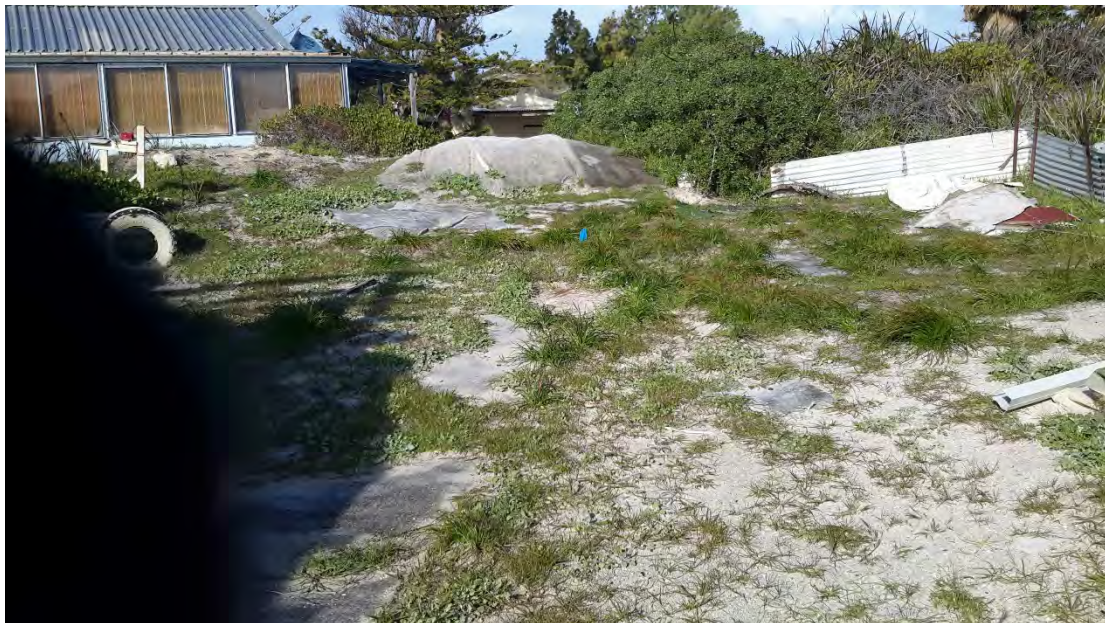
**Photo 12.: Common area between W13 and W25 classified as 'outstanding'. Mound in Photo 11 in background.**

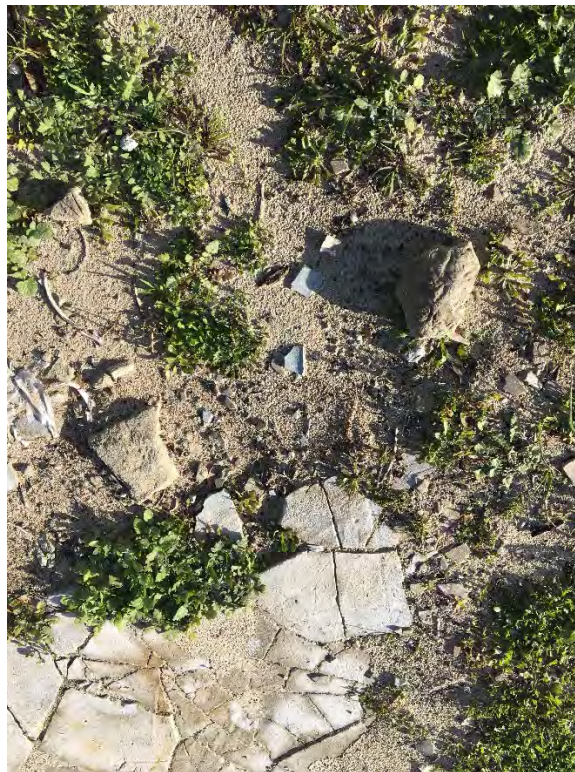
**Photo 16. Typical suspect ACM scatter (G63).**

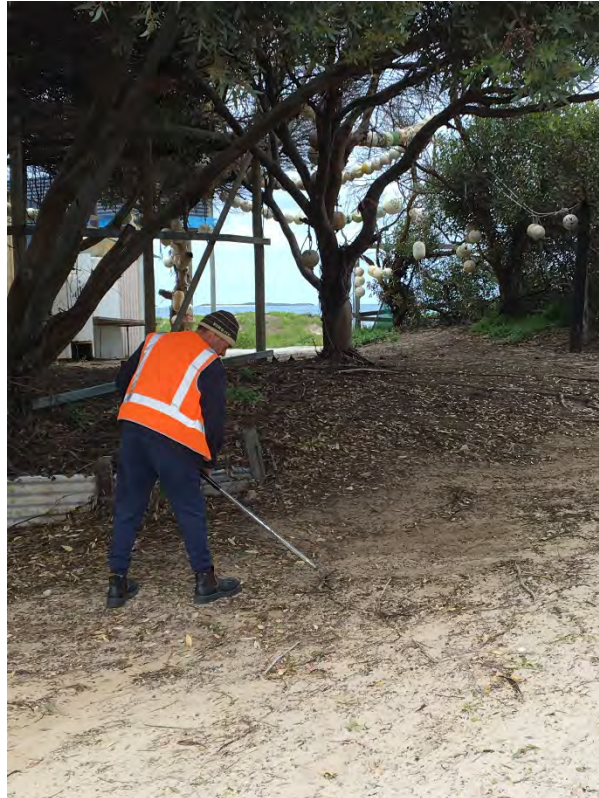
**Photo 19. Raking suspected ACM at G115.**

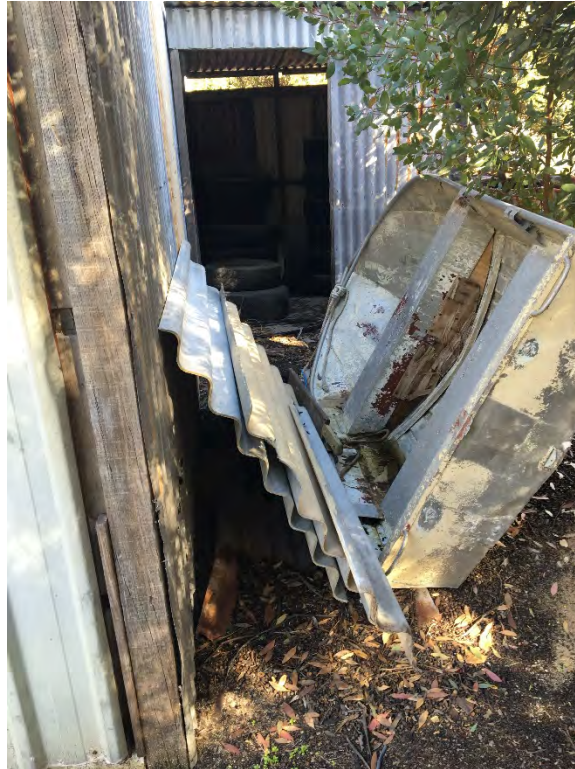
**Photo 20. Typical occurrence of suspect ACM sheets (G85).**

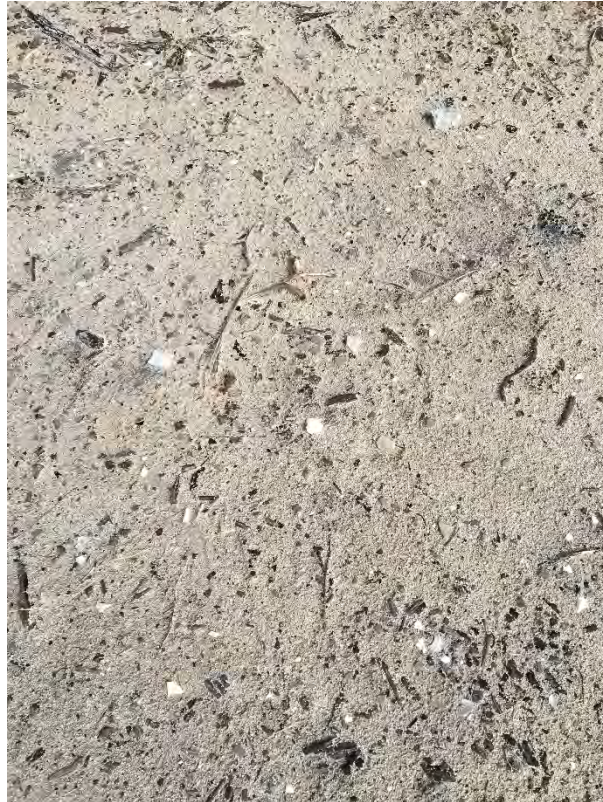
**Photo 21. Typical suspect ACM scatter on tracks (G43).**

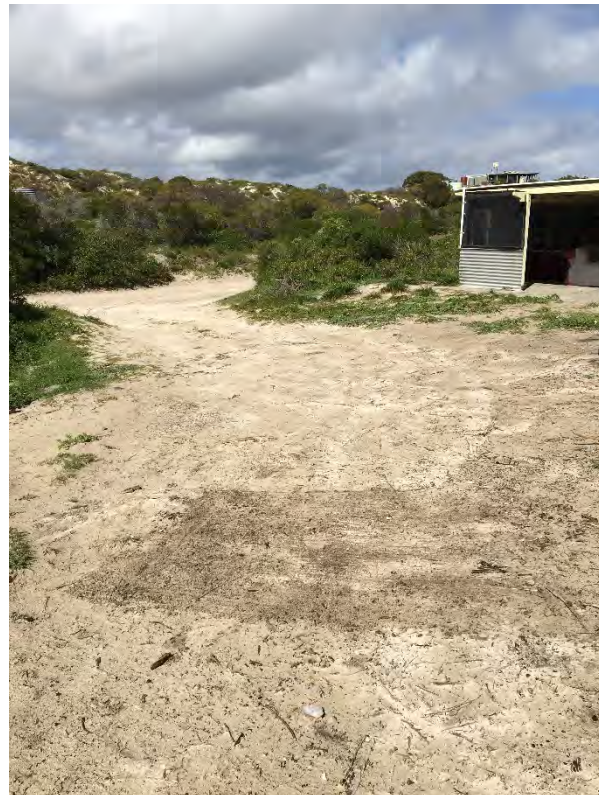
**Photo 22. Suspect ACM scatter near G43 post remediation.**
