Tributary Foreshore Assessment: Bennett Brook

Conservation and Ecosystem Management Division

March 2019

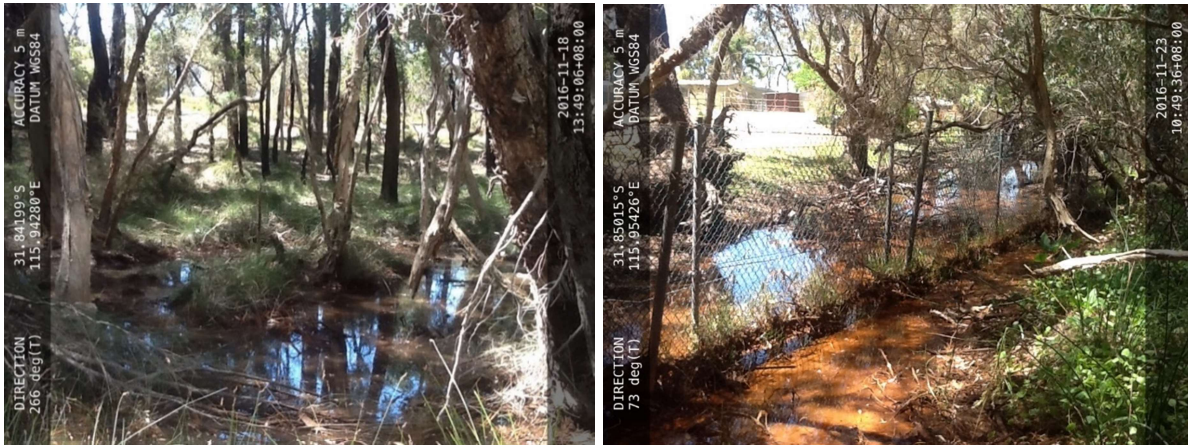
Bank stability is good for most of the North section (*Figure 24*). In only three segments erosion or sedimentation were noted. At the headwaters localised sedimentation was associated with a culvert on the Beechboro Road North crossing. A sand-based dam is located in the brook near the northern-most rail crossing (*Figure 22*). Near another rail crossing about 700m north of Mussel Pool, the rail embankment appears to have impeded water flow and the surface water was stagnant (*Figure 20*).

Figure 20 (left): Slow-flowing to stagnant water north of Mussel Pool.

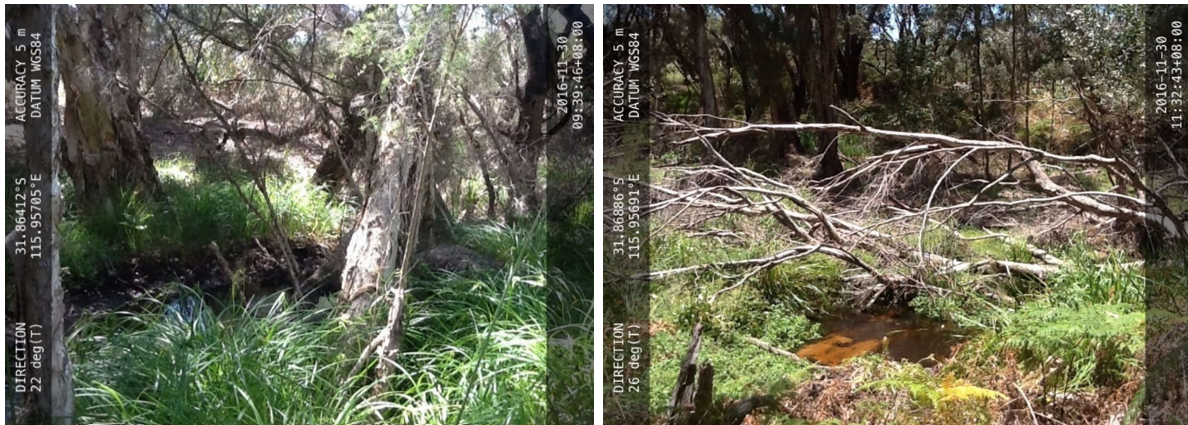
Figure 29 (left): Typical bank structure in the Central section.
 Figure 30 (right): Small areas of localised sedimentation only were found.

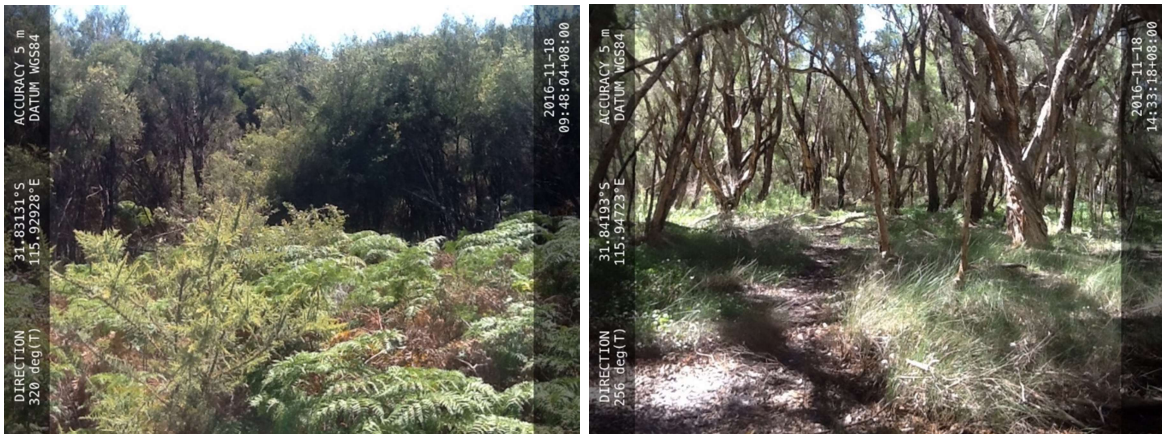
Figure 55 (left): Bracken fern is dominant in areas of the upper bank.

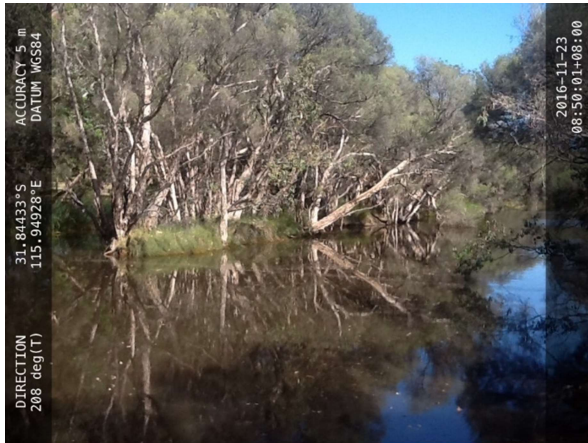
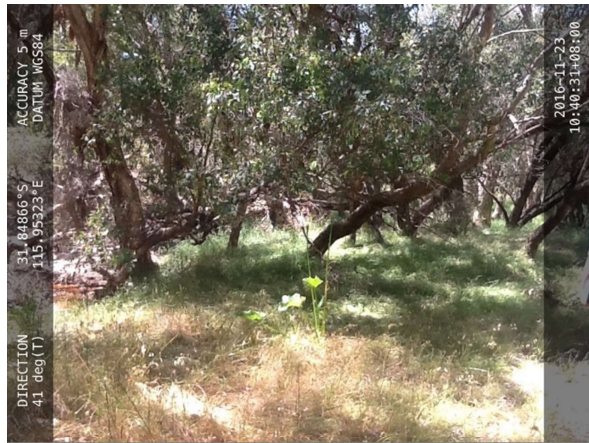
Figure 57 (left): Riparian vegetation around Mussel Pool.
 Figure 58 (right): Weed dominated vegetation south of Mussel Pool.

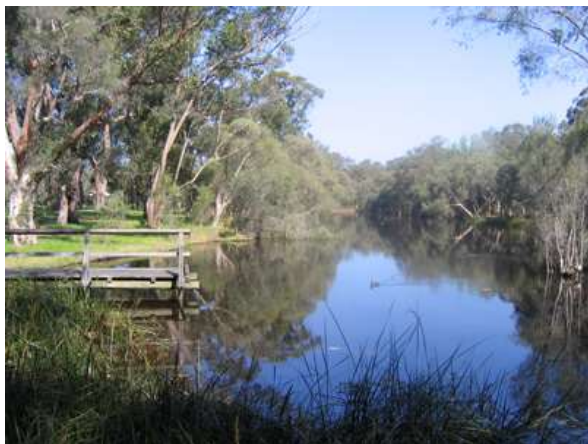
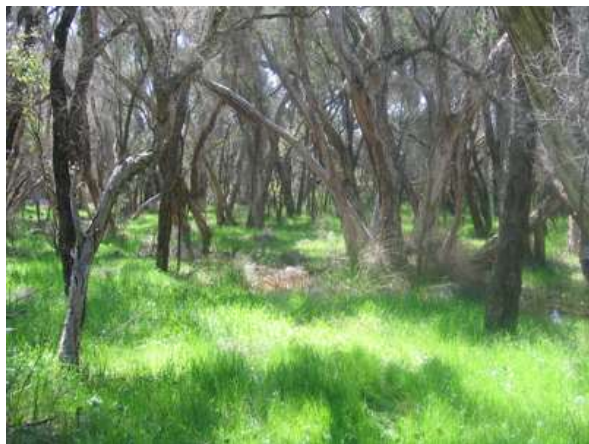
Figure 59 (left): Mussel Pool in 2007.
 Figure 60 (right): Understorey south of Mussel Pool dominated by weeds in 2007.

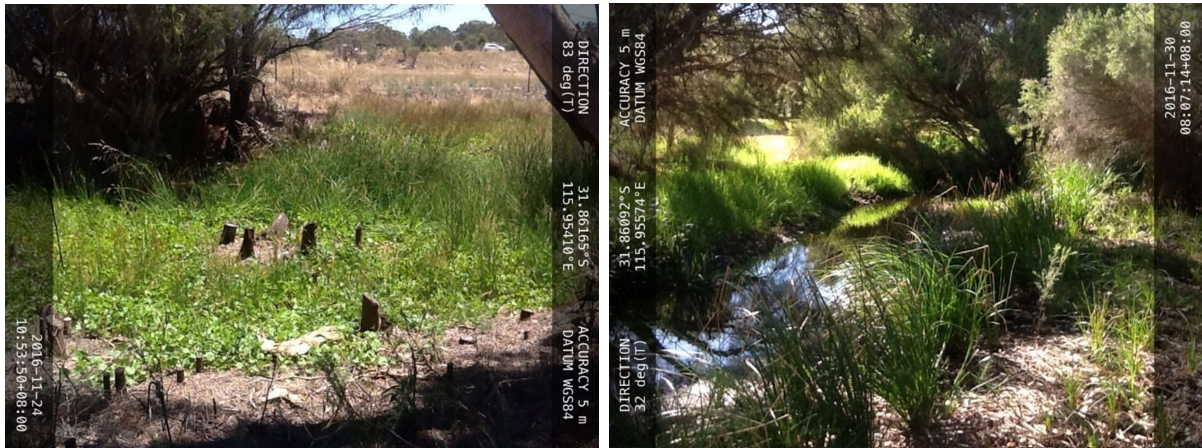
Figure 62 (left): Some mature *Acacia saligna* were removed from Bandicoot Creek to prevent the spread of *Acacia gall rust*.

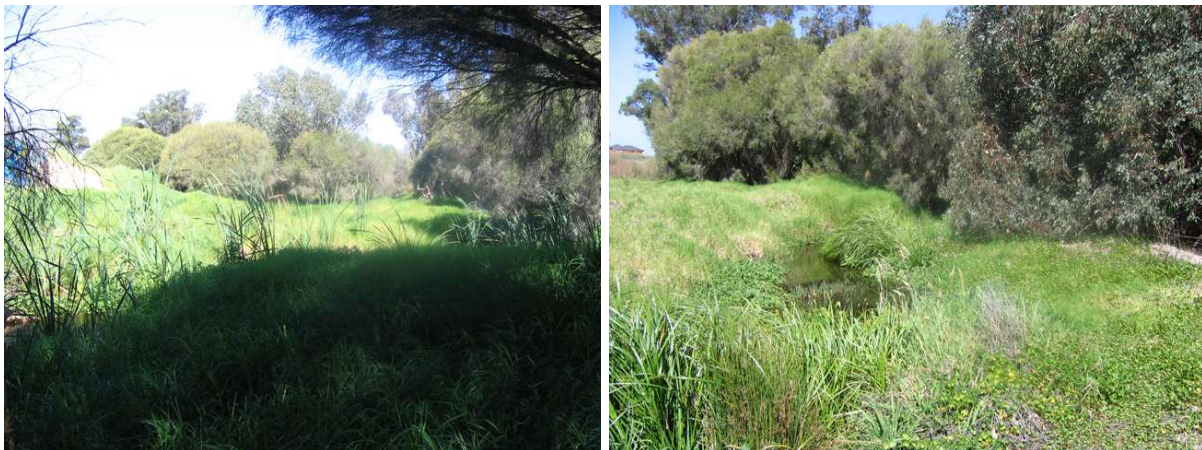
Figure 64 (left) and Figure 65 (right): *Kikuyu* dominated understorey near the Bandicoot Creek confluence in 2007.

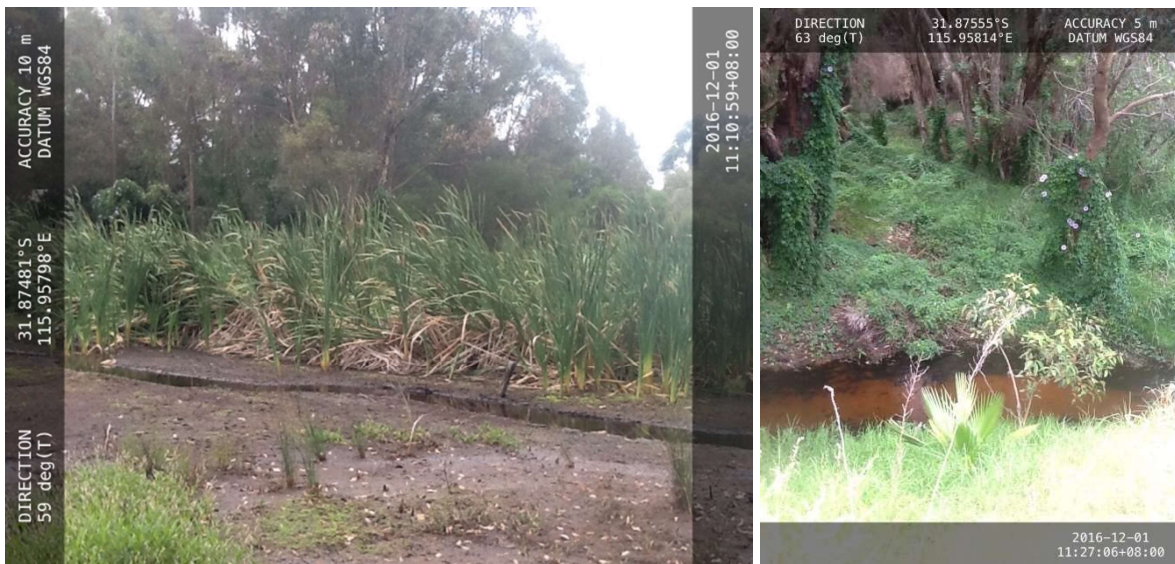
Figure 68 (left): *Typha* population north of Benara Road that Friends of Bennett Brook have removed in stages.

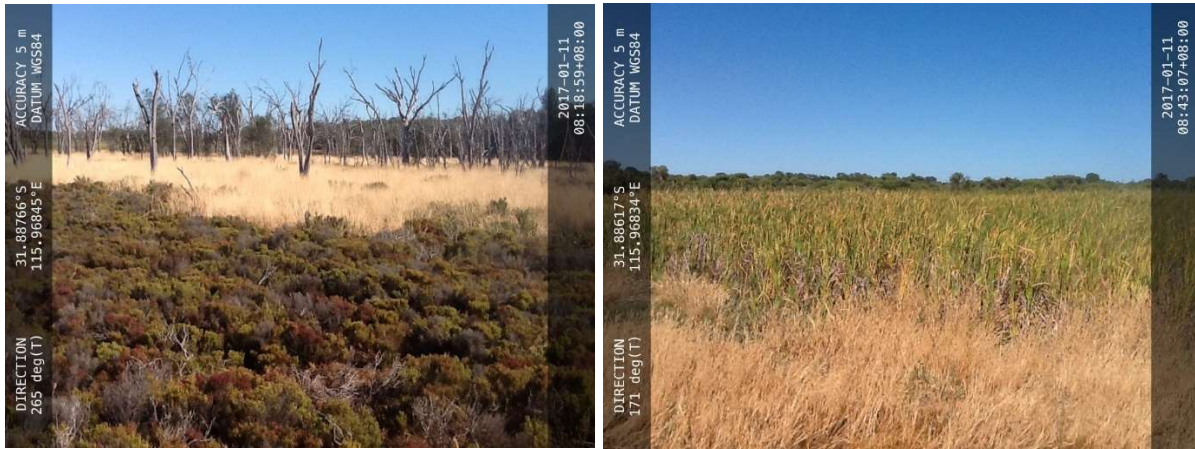
Figure 81 (left): Samphire flats with dead swamp sheoak in the background.
 Figure 82 (right): *Typha* population on the eastern side of Grogan Swamp.

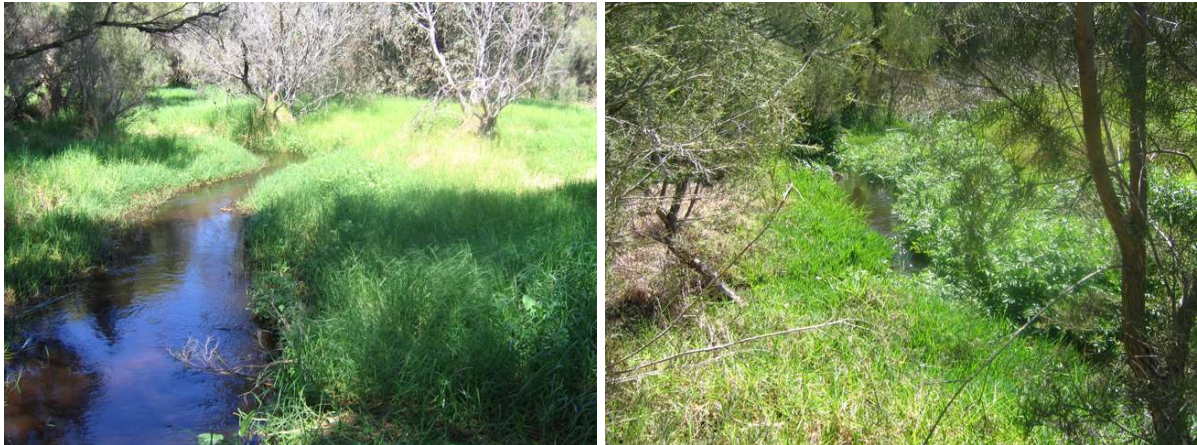
Figure 98 (left) and Figure 99 (right): Weed dominated understorey north of Reid Highway in 2007.

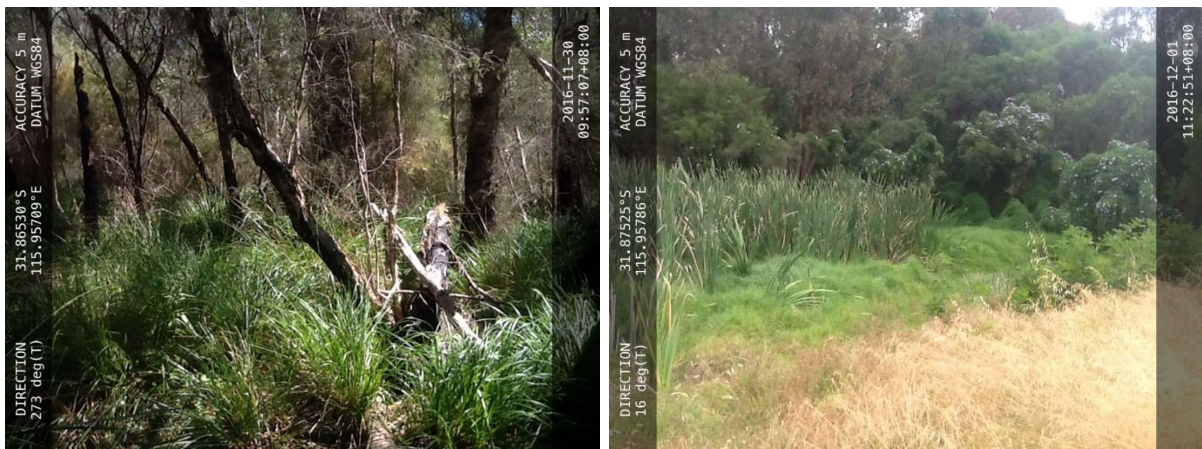
Figure 100 (left): In many areas between Bandicoot Creek and Simla Park the native sedge *Carex fascicularis* has outcompeted what had been a weedy understorey.
 Figure 101 (right): Dense kikuyu and morning glory infestation north of Benara Road.

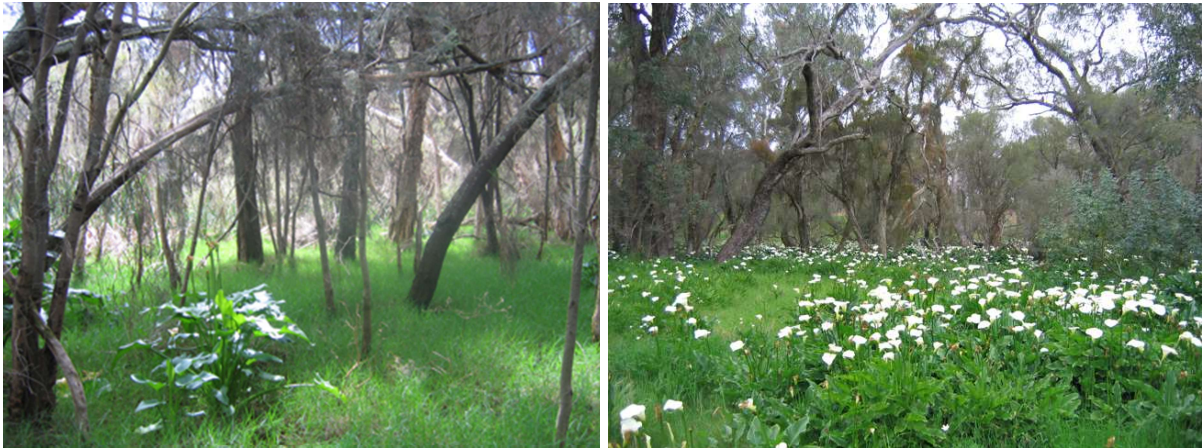
Figure 107 (left): Grass dominated understory on eastern side of Grogan Swamp, 2007.
