## **Remedial Detailed Site Investigation**

### **Wedge and Grey Shack Settlements**

Department of Parks and Wildlife

18 May 2017

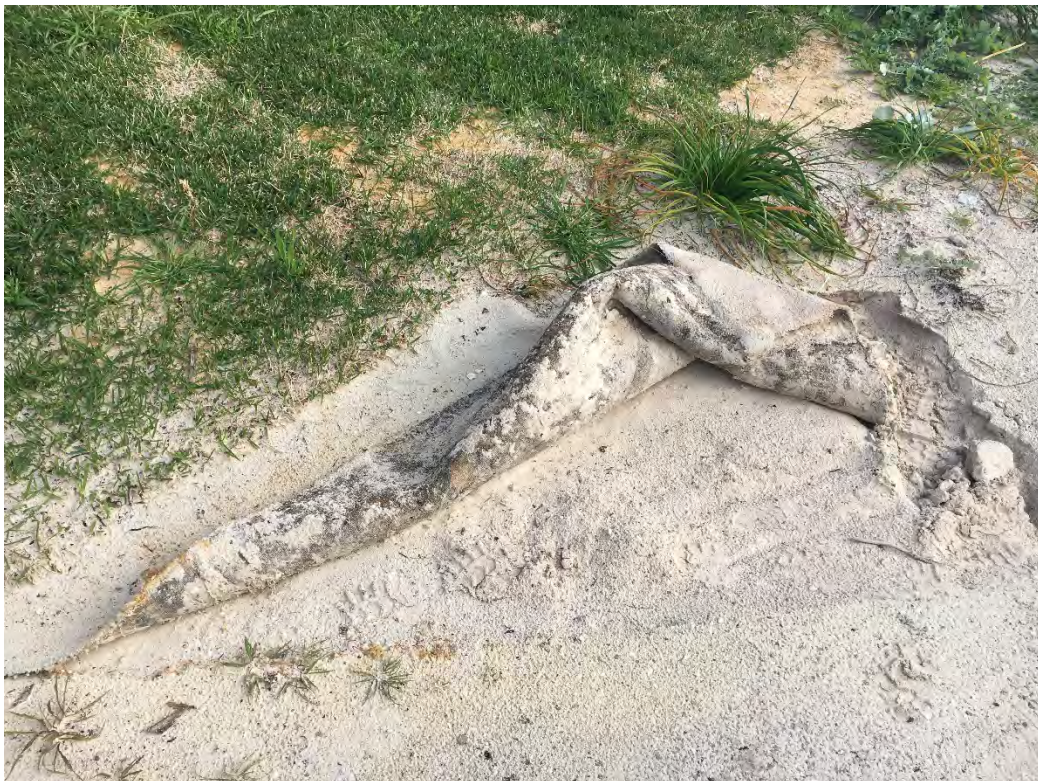
**Photo 6. Example of typical carpet upturned during the ACM identification and removal assessment.**

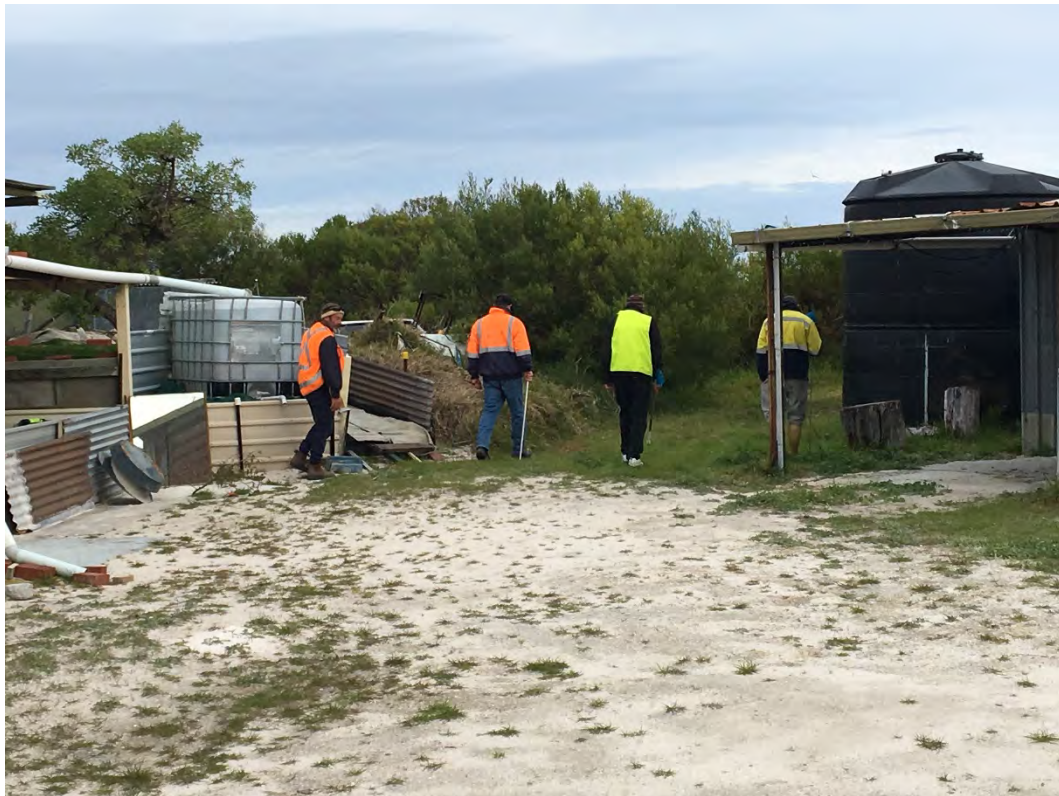
**Photo 9. Sub-contractors undertaking ACM identification walkover.**

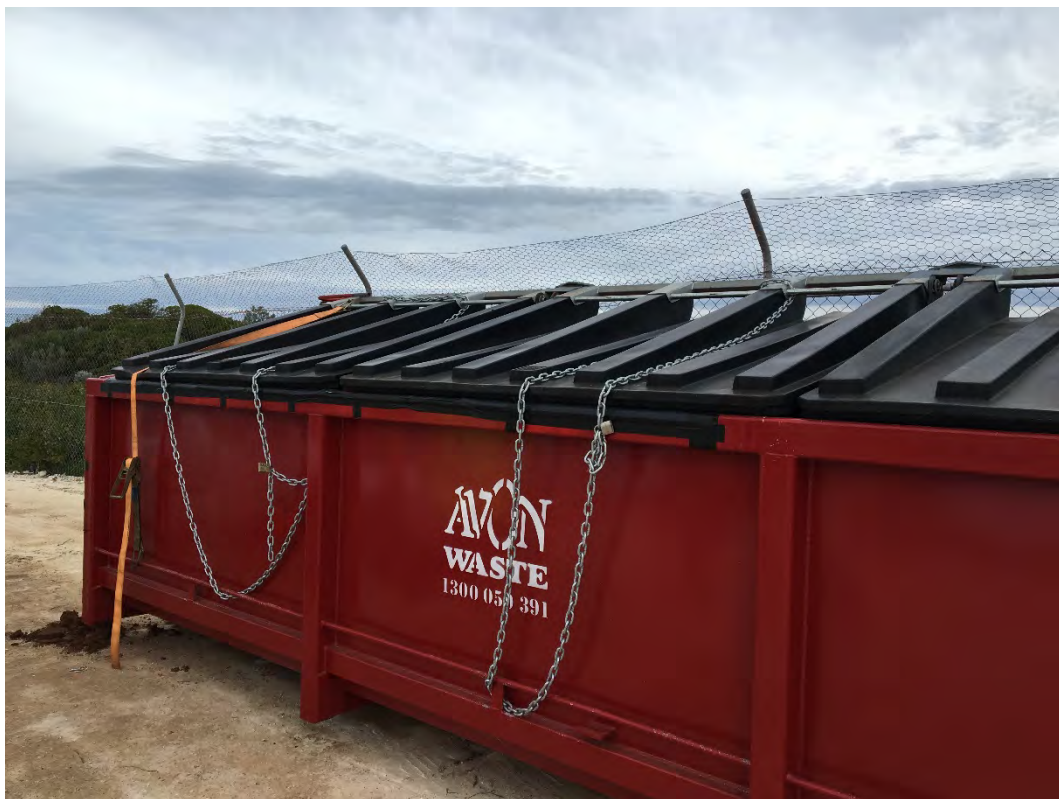
**Photo 10. Lockable skip bin for suspect ACM storage prior to its disposal.**
