Tributary Foreshore Assessment: Bennett Brook

Conservation and Ecosystem Management Division

March 2019

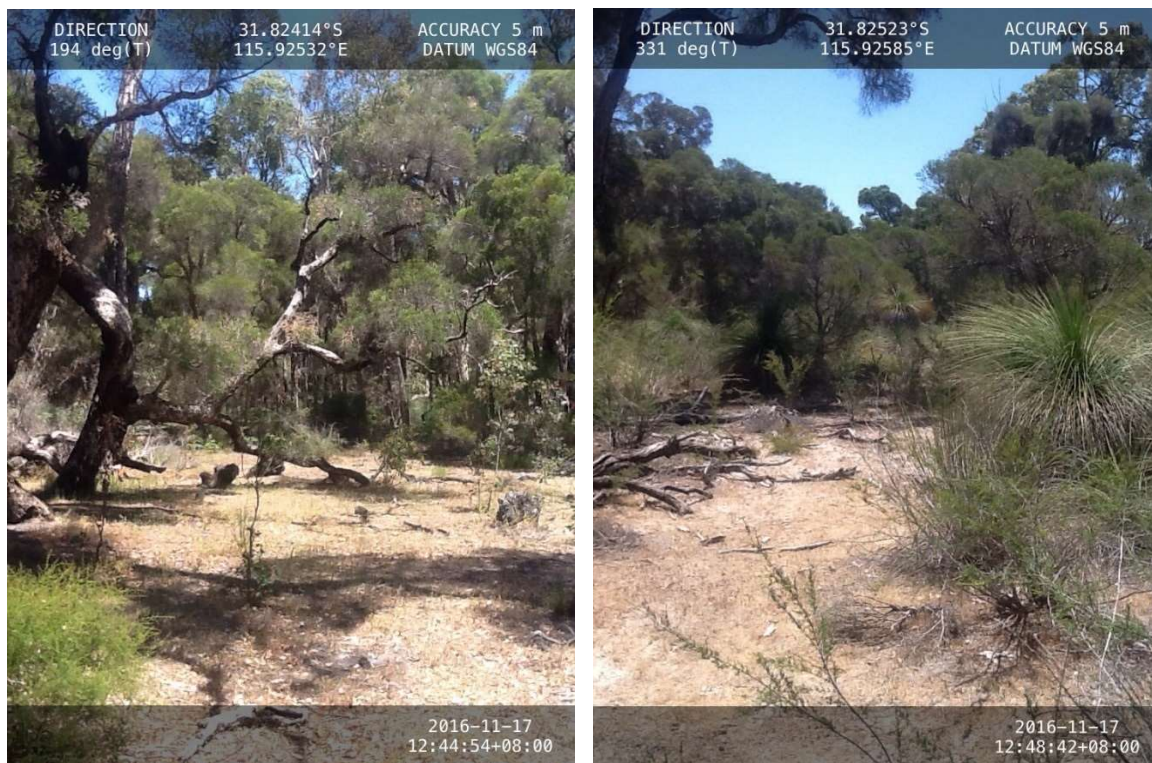
The headwaters of Bennett Brook are shallow and gently sloping (*Figure 18-19*). The channel is difficult to distinguish as the landscape is flat and riparian vegetation is dispersed among dryland plants.

Figure 18 (left) and Figure 19 (right): Shallow, undefined banks near the headwaters.

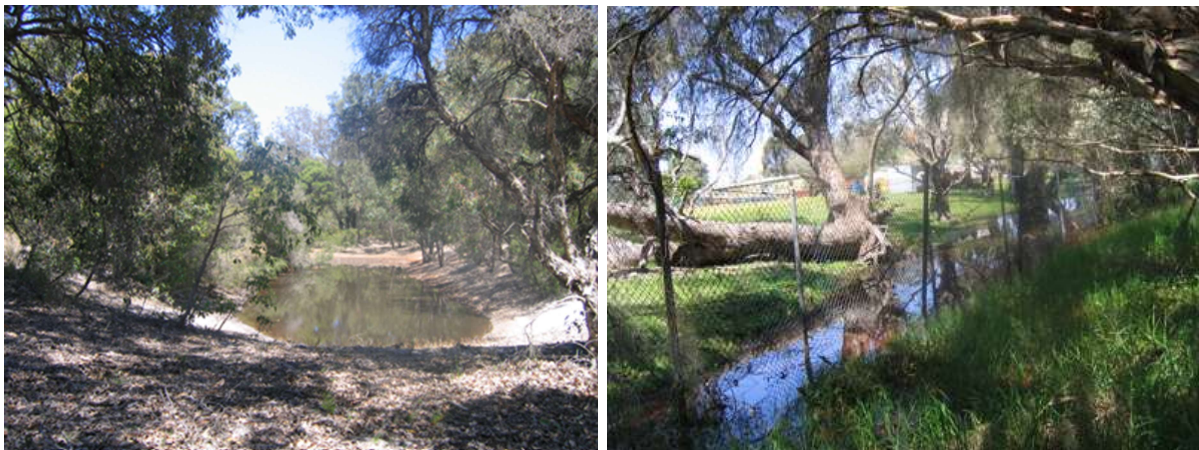
Figure 22 (left): Small dam on Bennett Brook in 2007 (was dry in 2017).

Figure 23 (right): The private property fenceline in 2007.

Towards Marshall Road and adjacent to private property bank stability was average where domestic sheep and pigs had access to the brook (Figure 21, Figure 23). This area was in a similar condition when assessed by DBCA in 2007.

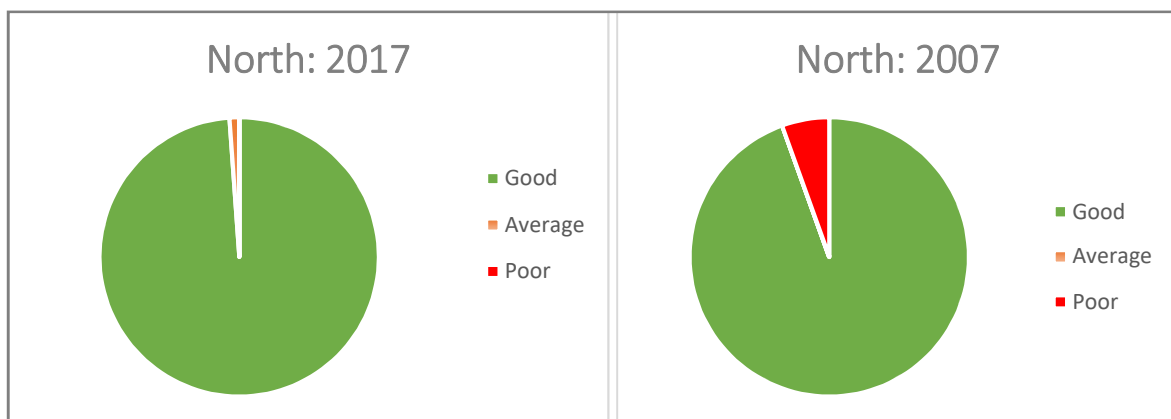
Bank stability is good for most of the North section (*Figure 24*). In only three segments erosion or sedimentation were noted. At the headwaters localised sedimentation was associated with a culvert on the Beechboro Road North crossing. A sand-based dam is located in the brook near the northern-most rail crossing (*Figure 22*). Near another rail crossing about 700m north of Mussel Pool, the rail embankment appears to have impeded water flow and the surface water was stagnant (*Figure 20*).

Figure 24: Bank stability ratings for the North section in 2017 (left) and 2007 (right).

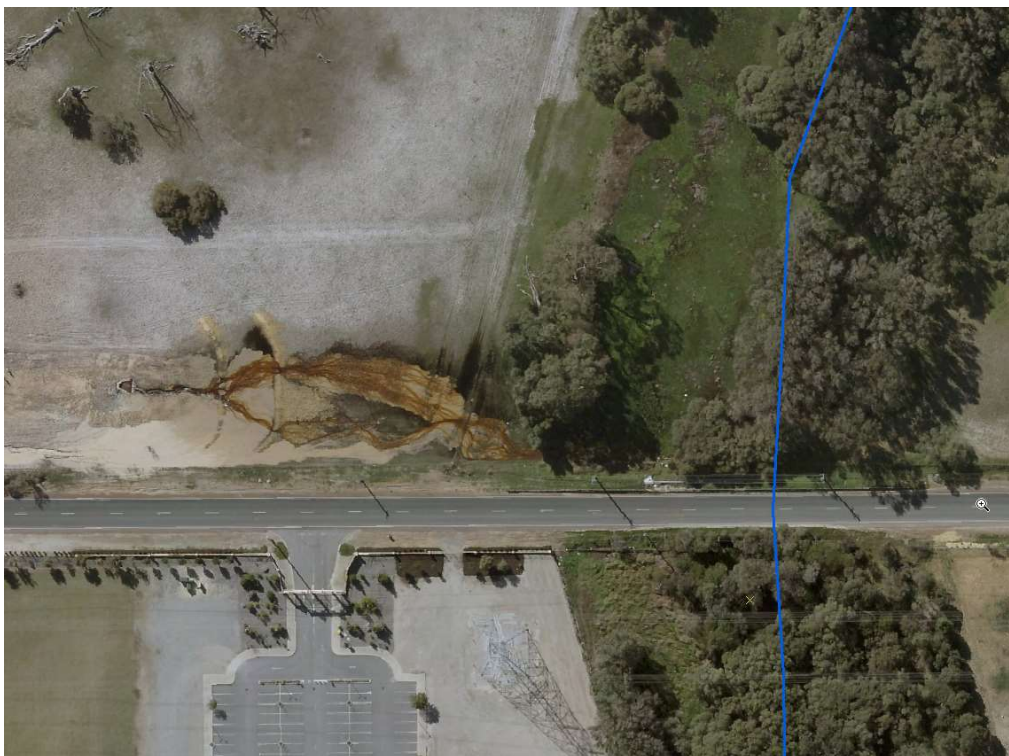
In winter 2018 the City of Swan redirected a drainpipe outlet to relieve flooding near houses on Marshall Road. However, the pipe was placed high on a slope, and the drop below the drainpipe onto sandy substrate together with the volume and speed of flowing water has resulted in severe gully erosion and sheeting of sand towards Bennett Brook. Some of the sand has been trapped by vegetation but a significant plume was visible at the Marshall Road crossing in September 2018 (*Figure 25*).

Figure 25: Sediment plume evident on the north side of the Marshall Road crossing.

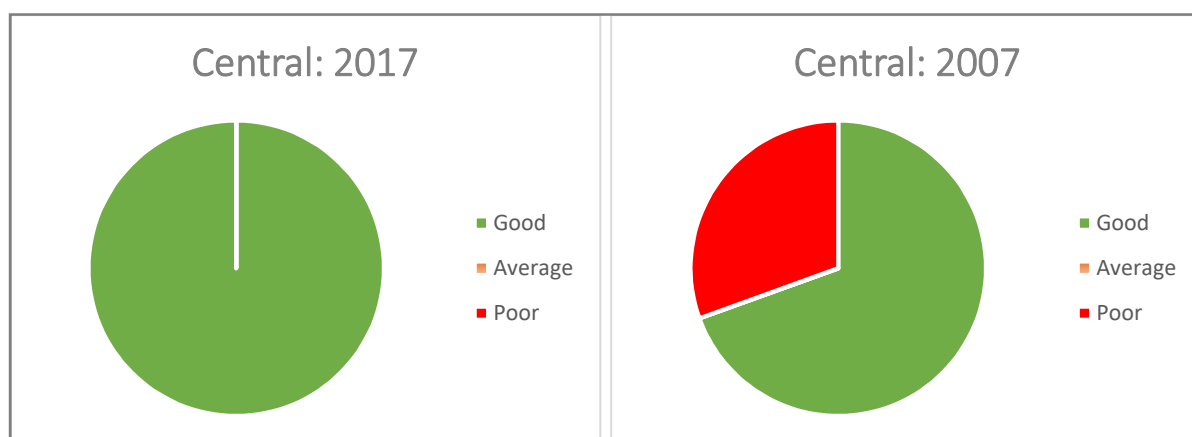
Throughout the Central section erosion is not apparent and bank stability is good (*Figure 28*). Most of the section has been revegetated and has good coverage of sedges, understorey plants and tree roots (*Figure 29*). In the short reaches that have not yet been revegetated a dense kikuyu layer helps to provide bank stability. In 2007 bank stability was average or poor in nine of the 21 segments that had been assessed, indicating a substantial improvement in bank condition since then.

Figure 28: Bank stability ratings for the Central section in 2017 (left) and 2007 (right).

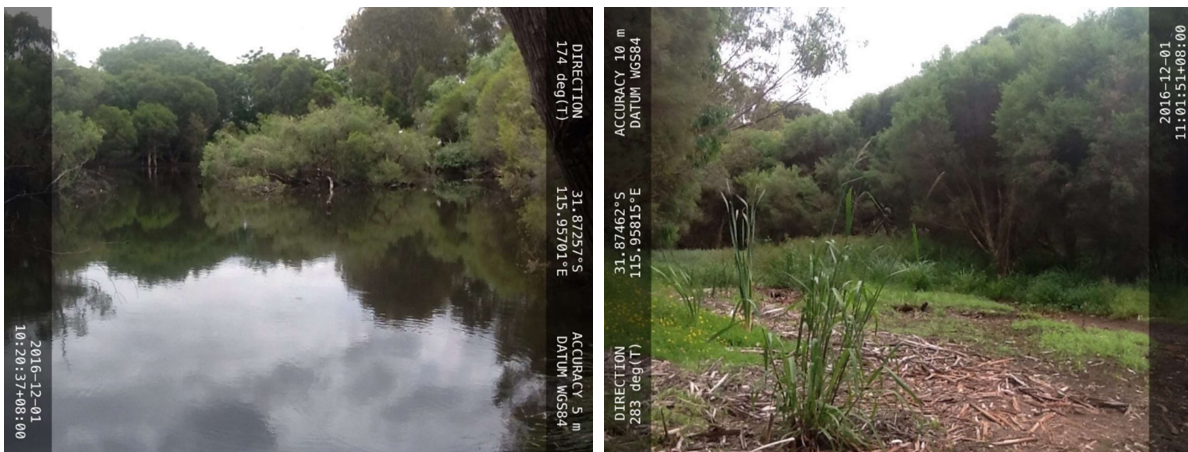
There are several braided channels and an open waterbody in the lower reaches of the Central section (Figure 31-Figure 34). In 1998 the high level of weed invasion in the channels had resulted in slow stream flow and extensive retention of sediment from upstream erosion (WRC 1999). Where private property is adjacent to the left bank of the brook weed invasion is still high but where it is possible to see the bank, stability is good, and erosion and siltation issues are not evident.

Figure 31 (left): Open waterbody on Bennett Brook 350m north of Benara Road.
 Figure 32 (right): Open shallow channel near Benara Road.

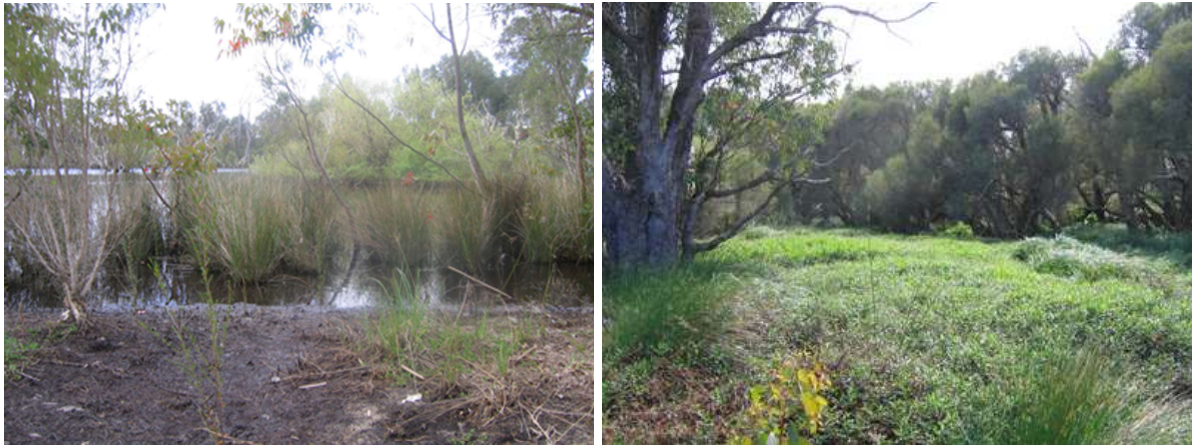
Figure 33 (left): Waterbody in 2007.
 Figure 34 (right): Shallow channel in 2007.

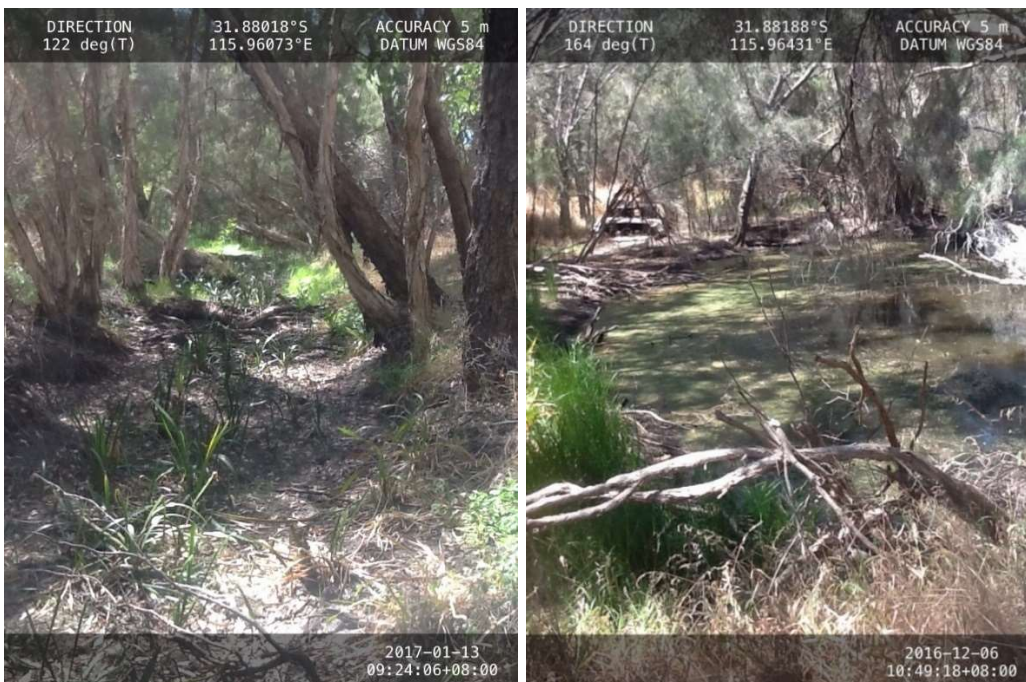
Close to Grogan Swamp there are multiple channels and high embankments where the drainage appears to have been modified (Figure 35, Figure 37). In 2007 some erosion and siltation was observed, but this was not visible in 2017 due to the dense vegetation and inaccessible banks.

Figure 35 (left): Multiple channels upstream of Grogan Swamp.
 Figure 36 (right): Open water and swamp paperbark woodland in Grogan Swamp.

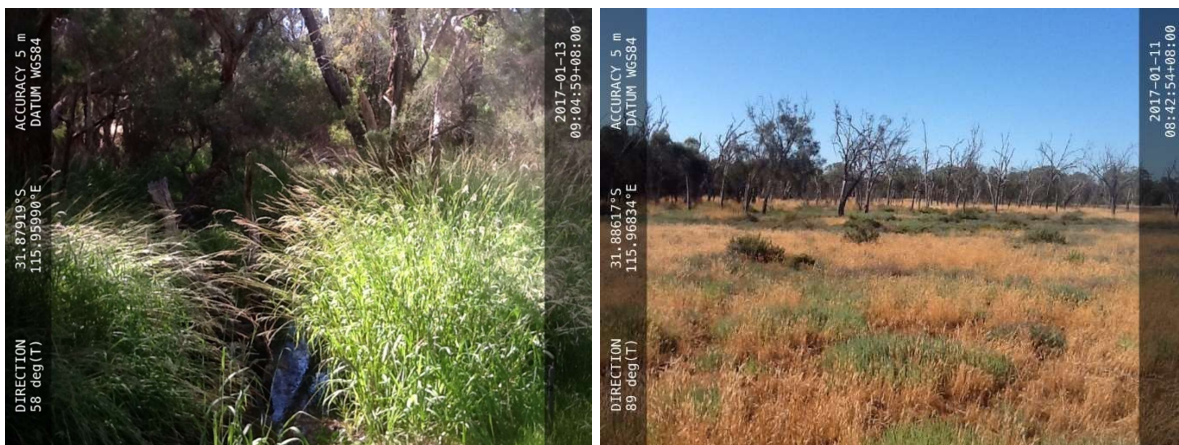
The floodplain opens out around Grogan Swamp and there are several open areas of surface water within the swamp system (Figure 36). The banks are shallow and low. On the eastern side of the swamp several claypans and low-lying cracking clays flood during high rainfall events (Figure 39).

A Water Corporation drain flows into the swamp from west of Lord Street. A series of drainage channels that interconnect with the Water Corporation drain are located near the Bennett Brook Disability Justice Centre and the Swan Valley Nyungah Community site (Figure 38).

Figure 38 (left): Drainage channels on the western side of Grogan Swamp.

Figure 39 (right): Low-lying floodplain on the eastern side of Grogan Swamp.

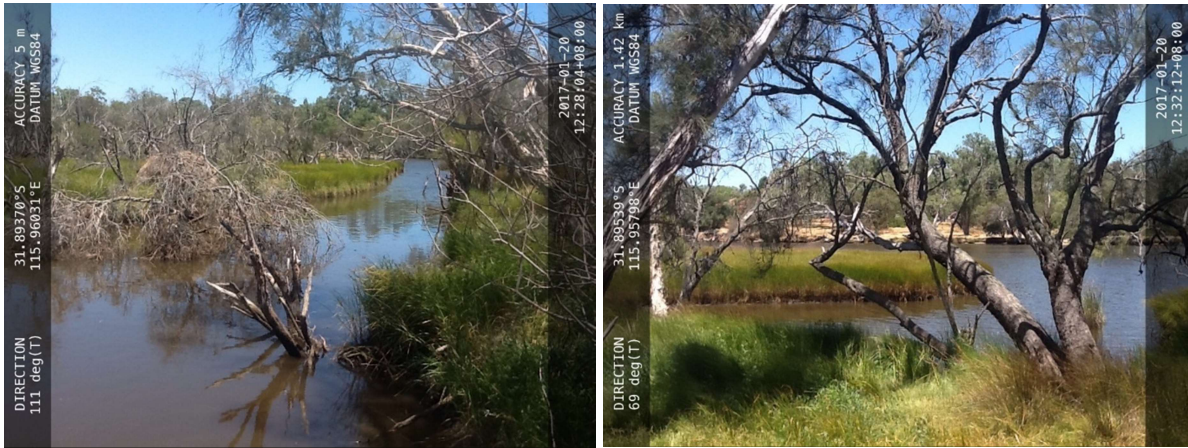
Downstream of Grogan Swamp the brook becomes a single channel that flows into the Swan River (Figure 40-Figure 43). The banks range from 1-2m to >2m high but are gently sloped. Some erosion was noted in this area where the banks are undermining. Bank stability is average. Erosion was also recorded in 2007, where the bank was exposed and several *Casuarina obesa* (swamp sheoak) trees had fallen over. The WRC assessment did not include this section of Bennett Brook.

Figure 40 (left) and Figure 41 (right): Confluence of Bennett Brook and the Swan River.

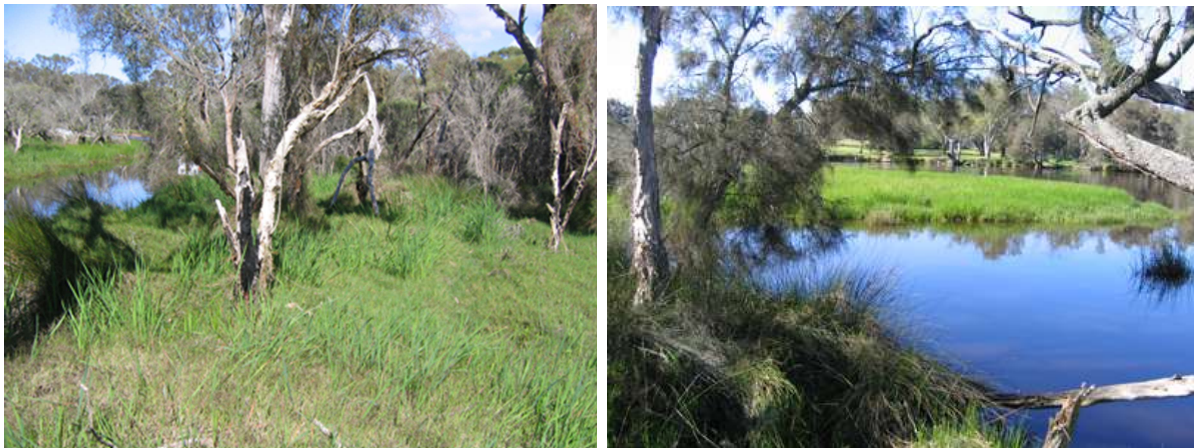
Figure 42 (left) and Figure 43 (right): Confluence in 2007.

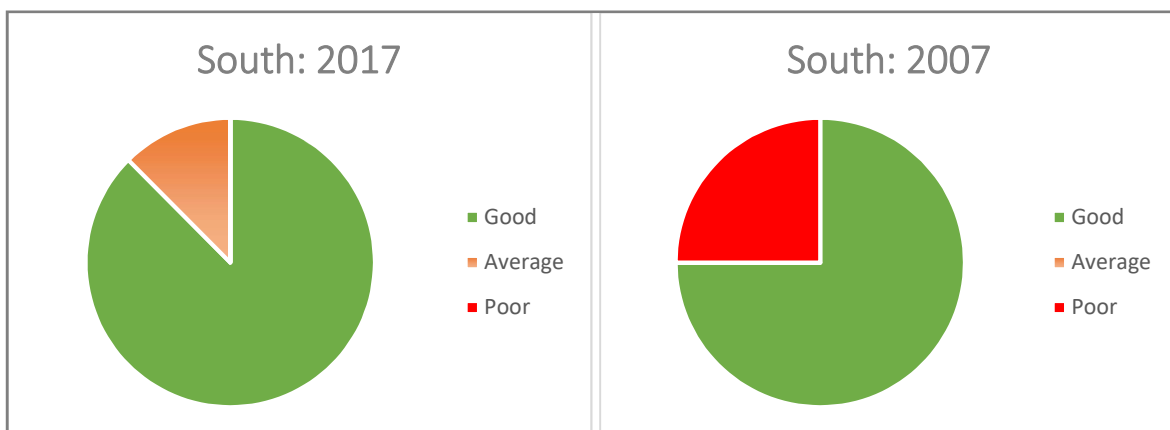
South of Benara Road the brook splits into several channels. In Clarry Small Park the banks are >2m high and the slope is medium to steep. There is a cleared paddock at the south of Clarry Small Park where old farming infrastructure is present and the channel opens out, possibly modified drainage for the farm. Bank stability is average due to the exposed bank (Figure 44).

Figure 44: Bank stability ratings for the South section in 2017 (left) and 2007 (right).

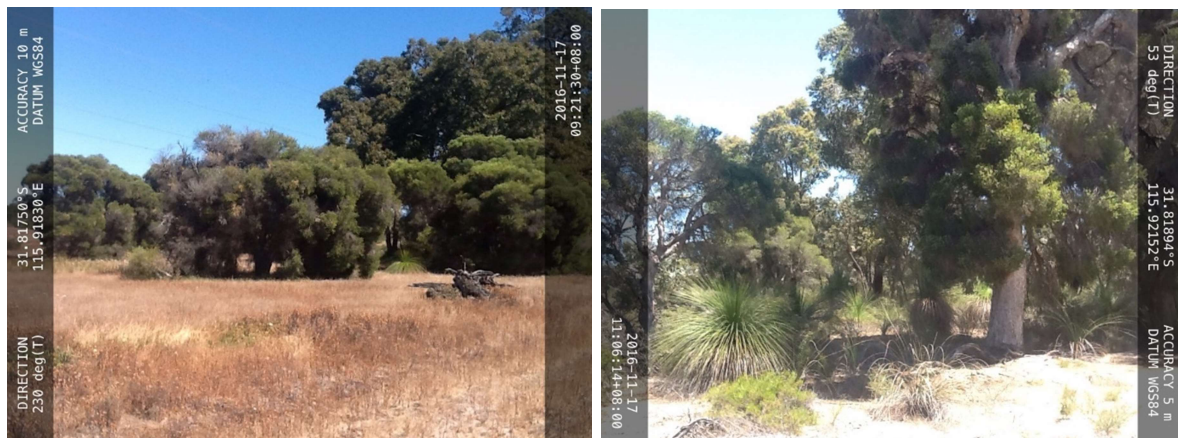
The vegetation in the headwaters of Bennett Brook (west of Beechboro Road North) has been impacted by grazing and historic clearing, and the understorey is comprised of mixed weedy grasses and virtually no native species (*Figure 51*). Vegetation condition is poor in this segment.

Figure 51 (left): Headwaters of Bennett Brook west of Beechboro Road North.
Figure 52 (right): Undefined channel east of Beechboro Road North.

East of Beechboro Road North where the brook enters Whiteman Park the vegetation is more representative of its remnant form prior to European settlement (Figure 52, Figure 54). Species are diverse and dominant genera include *Banksia*, *Xanthorrhoea*, *Melaleuca* and *Corymbia*. Vegetation condition is good.

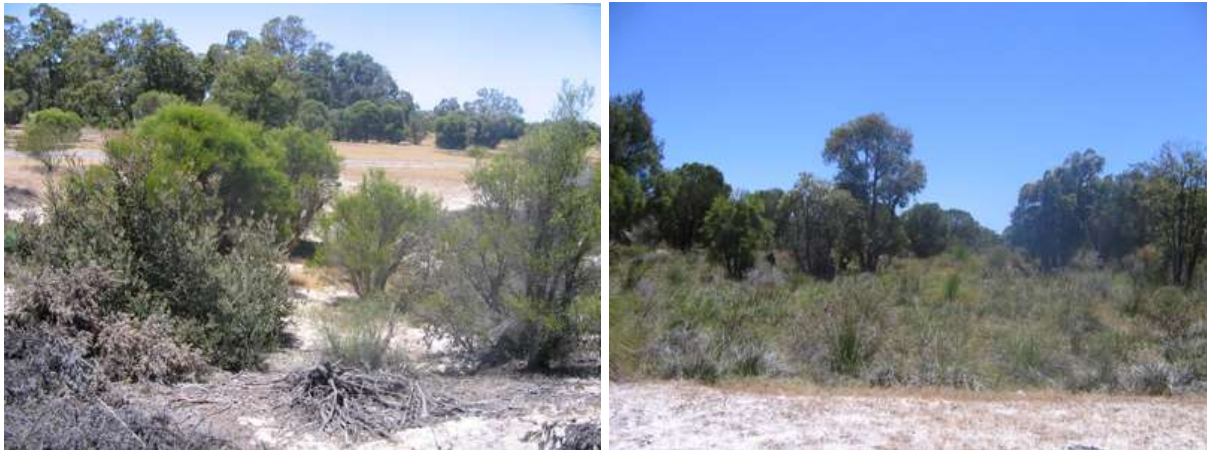
Figure 53 (left): Headwaters west of Beechboro Road North in 2007.

Figure 54 (right): Headwaters east of Beechboro Road North in 2007.

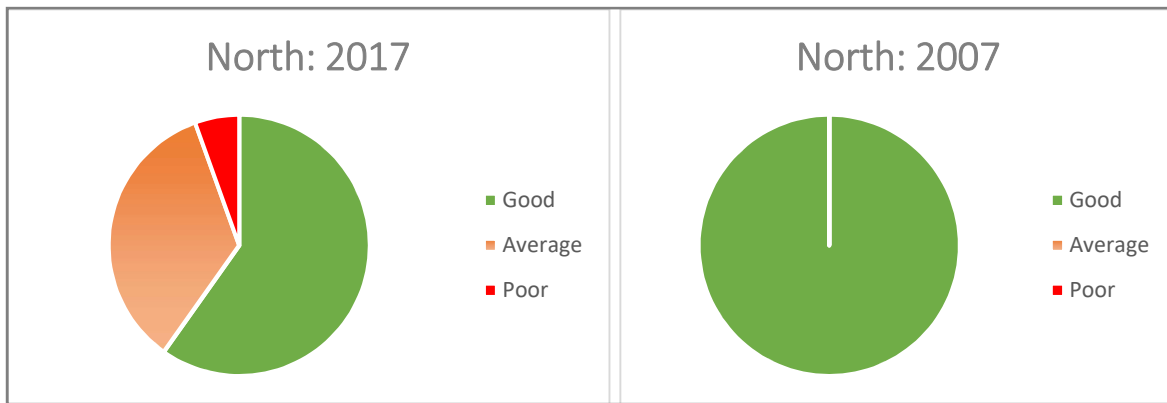
In 2007 vegetation condition for the entire section had been rated good (Figure 61), although weeds were prevalent from Mussel Pool downstream (Figure 59, Figure 60). The field assessors in 2007 may have placed greater emphasis on the apparent health of the remaining native vegetation (e.g. live canopy, no evidence of insect attack) rather than the resemblance of the overall vegetation composition to a pre-European-settlement state.

Figure 61: Vegetation ratings for the North section in 2017 (left) and 2007 (right).

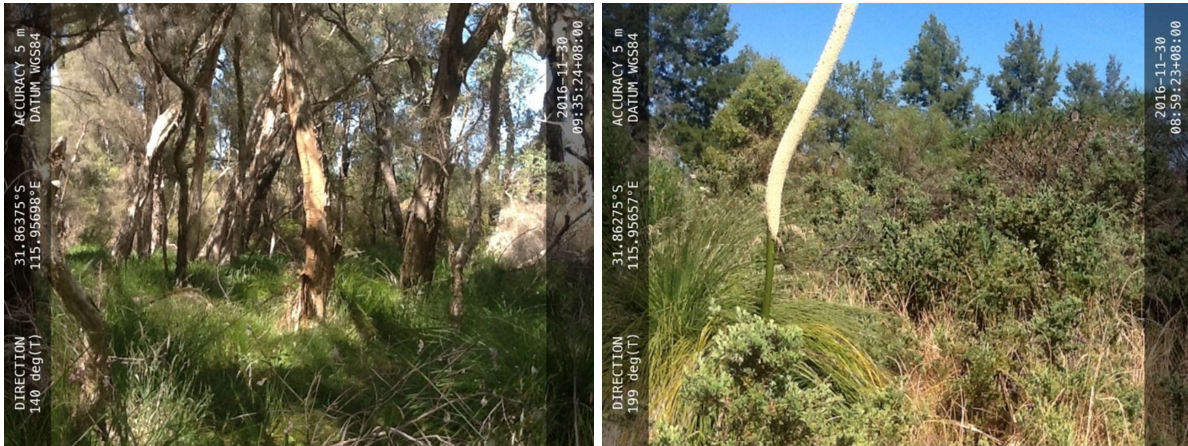
From Reid Highway to Simla Park, weed control and revegetation by the Friends of Bennett Brook is very evident. A remnant overstorey of flooded gum and swamp paperbark overhangs the channel. *Centella asiatica* and *Carex fascicularis* are extensive in the understorey (Figure 66). On the upper banks *Hakea*, *Corymbia* and *Jacksonia* species are dominant, with some grassy weeds amongst the understorey (Figure 67). Native species regeneration is evident from Reid Highway to Simla Park, where it is likely that the revegetation is amassing a seed bank and seedlings are not competing with weeds. Vegetation condition is average, due to the decreased coverage of weeds in the understorey.

Figure 66 (left): Extensive understorey of *Carex fascicularis*.

Figure 67 (right): A densely revegetated upperbank of dryland species.

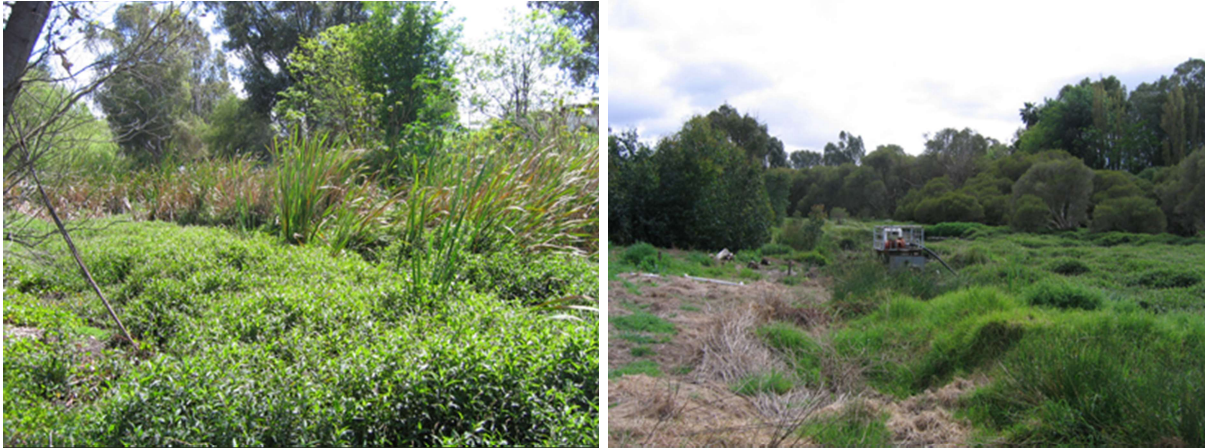
Immediately north of Benara Road the Friends of Bennett Brook have removed most of a dense infestation of *Typha* because of its impact of slowing water flow and sedimentation (Figure 68-Figure 71). There is also currently a large infestation of *Ipomoea cairica* (morning glory). In 1998 *Typha* was dominant in this area and *Watsonia* sp. was present. Vegetation condition was rated very poor.

Figure 70 (left): *Typha* population north of Benara Road in 2007.

Figure 71 (right): Dense kikuyu infestation north of Benara Road in 2007.

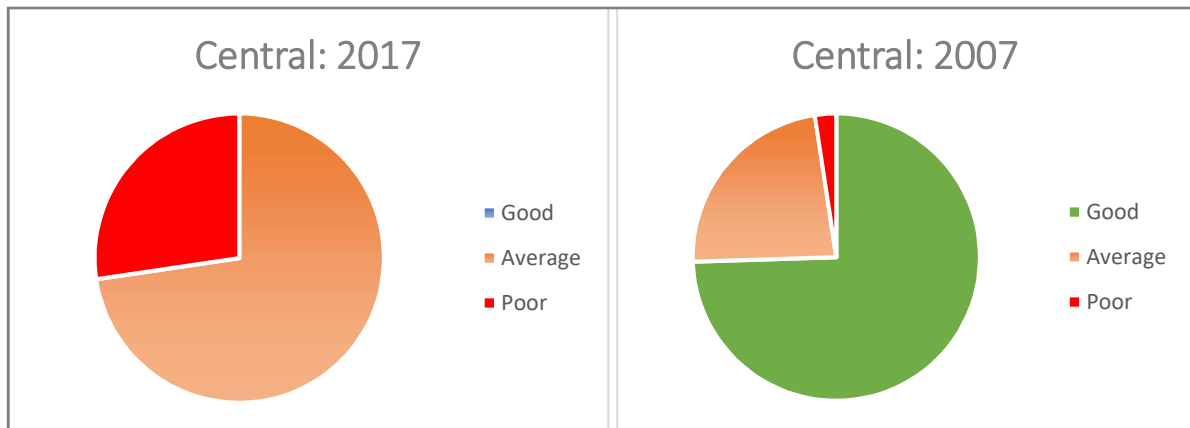
In 2007, vegetation condition was considered good from Marshall Road to St Elias Park (500m upstream of Simla Park), presumably due to the intact overstorey as weed coverage ranged up to extensive. It was rated average for most of the rest of the section to Benara Road (Figure 72). Weed control was evident in 2007.

Figure 72: Vegetation ratings for the Central section in 2017 (left) and 2007 (right)*.

*Note comments made above in the discrepancy of ratings between 2007 and 2017. It is unlikely that vegetation condition has declined. Photos taken during the 2007 assessment indicate that vegetation condition if evaluated by 2017 field assessors would have been rated as poor for most of this section.

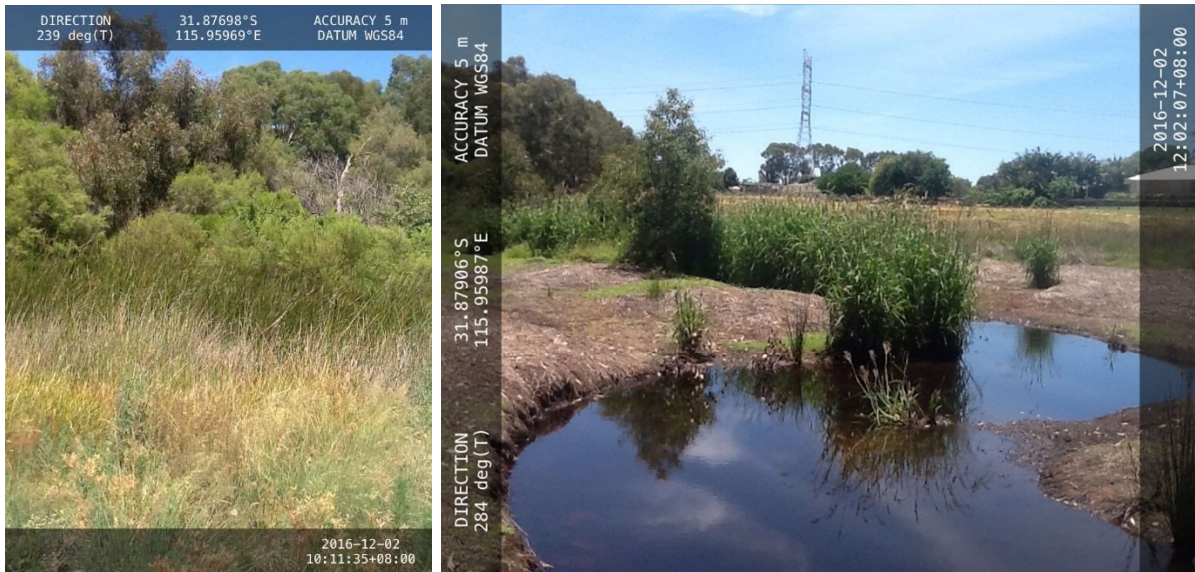
At the northern end of Clarry Small Park there is a dense overstorey of flooded gum and swamp paperbark, with *Typha* common in the midstorey following on from the dense upstream infestation. Native species have been planted on the upper banks, including *Banksia*, *Astartea* and *Hakea* species (Figure 73, Figure 75). Vegetation condition is average.

At the southern end of Clarry Small Park the cleared channel has no remaining native over or midstorey. The understorey is dominated by weeds, although control of arum lily is evident. Vegetation condition is poor (Figure 74, Figure 76).

Figure 73 (left): Dense instream vegetation at the north of Clarry Small Park.
 Figure 74 (right): Cleared channel at the south of Clarry Small Park.

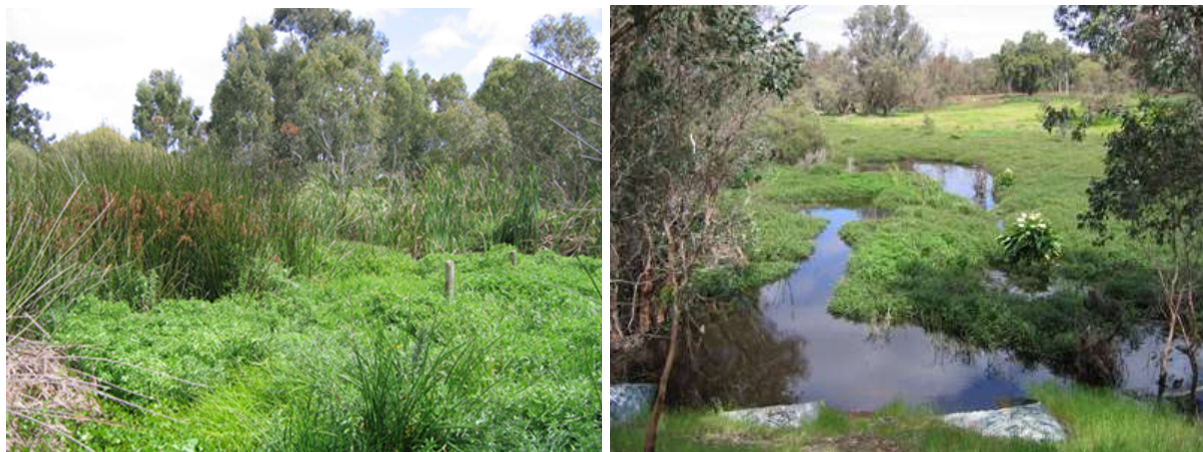
Figure 75 (left): Instream vegetation at the north of Clarry Small Park in 2007.
 Figure 76 (right): Cleared channel in Clarry Small Park in 2007.

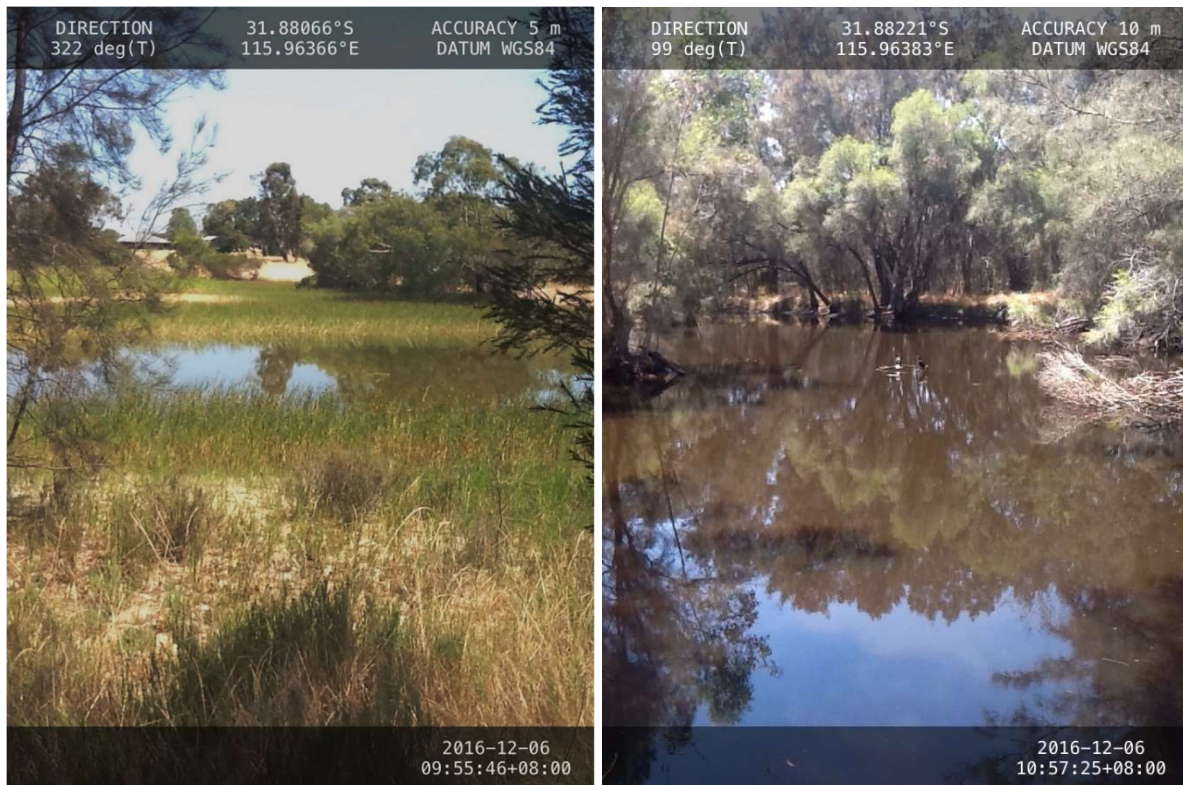
The claypans on the eastern floodplain are surrounded by sedges but behind this are infested with *Lolium* sp. (ryegrass) and *Avena barbata* (bearded oats) (Figure 77). The claypans are connected to the swamp via a vegetated floodplain and function as

an associated wetland, providing varied habitat from the wooded swamp. However, vegetation condition is poor due to the extensive coverage of weedy grasses.

Figure 77 (left): Claypan on the eastern side of Grogan Swamp.

Figure 78 (right): An open water section of Grogan Swamp.

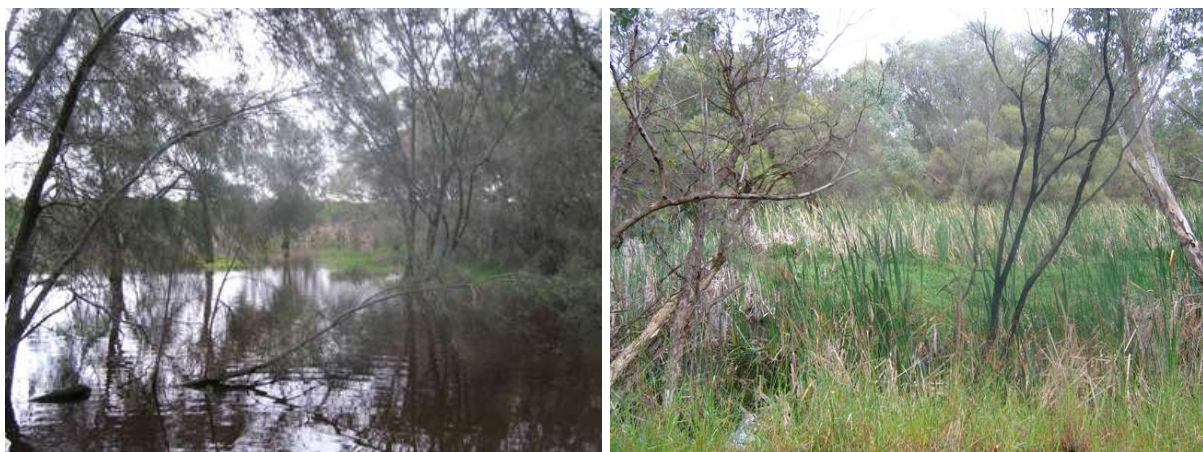
Grogan Swamp has significant stands of dense, mostly native vegetation comprising diverse ecosystems, including braided channels, claypans, open waterbodies, samphire flats and sedgeland. Much of the area is inaccessible by foot due to the density of vegetation and low-lying wet flats (Figure 78-Figure 80). A series of drains is also present on the western side that contain a native overstorey but many weed species.

Figure 79 (left): Open water body on the eastern side of Grogan Swamp, 2007.

Figure 80 (right): *Typha* population on the north east of Grogan Swamp, 2007.

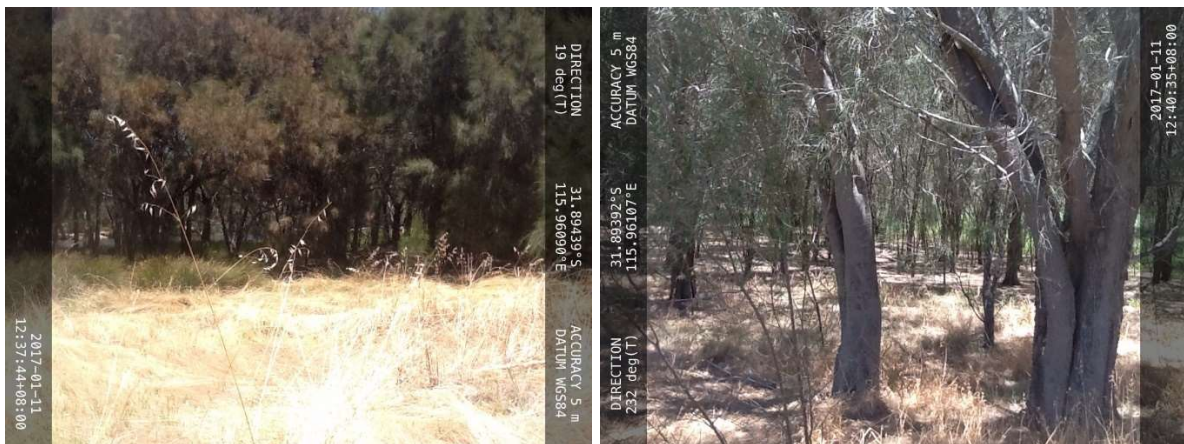
Swamp sheoak is dominant at the southern end of the swamp (Figure 83, Figure 85). Vegetation condition is poor where tree roots have been exposed on the undermining bank, and due to historic grazing on the eastern side of the brook.

Figure 83 (left) and Figure 84 (right): Dense swamp sheoak woodland on the lower reaches of Bennett Brook.

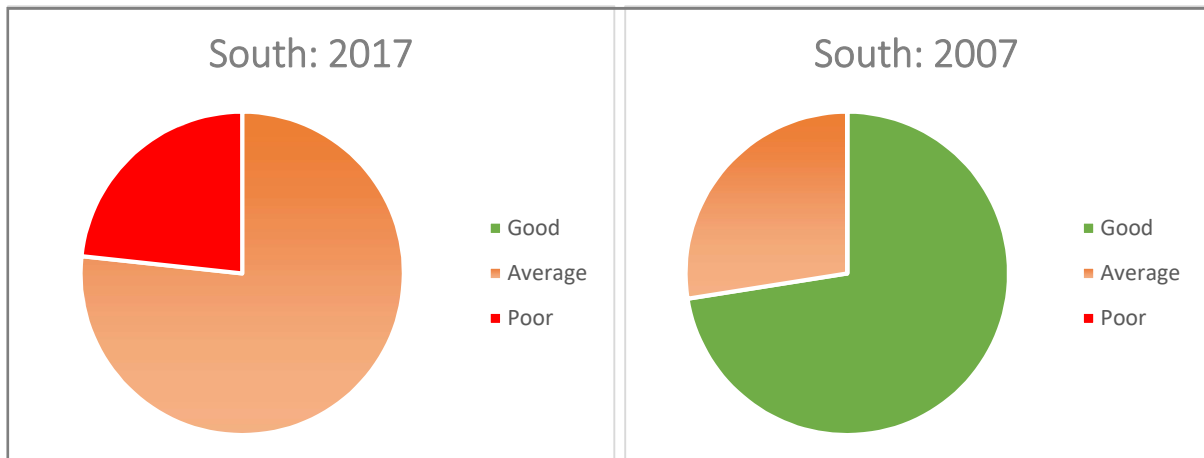
Figure 85: Vegetation ratings for the South section in 2017 (left) and 2007 (right).*

**The apparent decline in vegetation condition from 2007 to 2017 may be because the field assessors in 2007 placed greater emphasis on the apparent health of the remaining native vegetation rather than the resemblance of the overall vegetation composition to a pre-European-settlement state.*

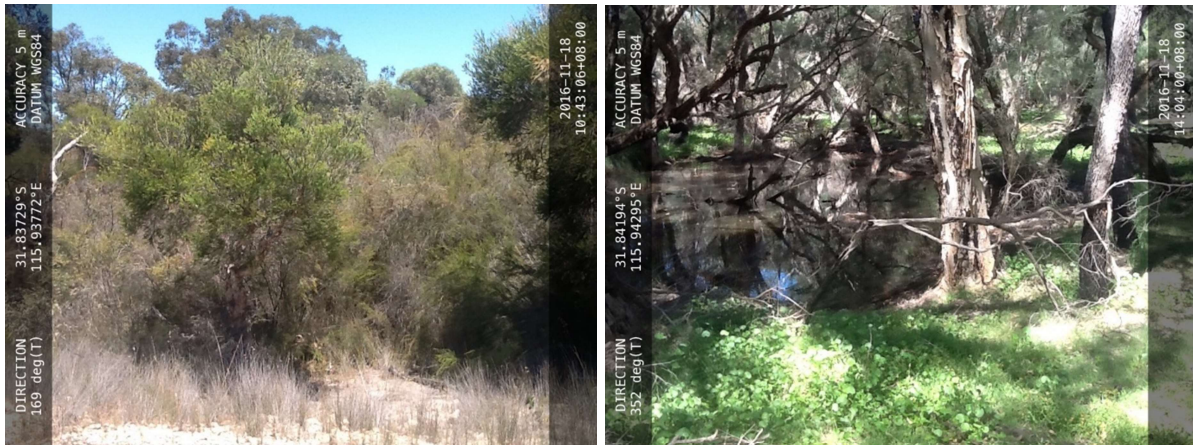
East of Beechboro Road North where Bennett Brook enters Whiteman Park, weed cover is minimal for about 3.5km. Weedy grasses including bearded oats, *Briza* sp. (blowfly grass) and *Eragrostis curvula* (African lovegrass), and herbs including *Hypochaeris* sp. (flatweed) and *Pelargonium capitatum* (rose pelargonium) are scattered on the upper banks (Figure 89).

Figure 89 (left): Scattered annual grasses on the upper bank.

Figure 90 (right): Grasses and herbs are common close to Mussel Pool.

From this point downstream to Mussel Pool, weed cover is mostly moderate (Figure 90). Common species include *Anagallis arvensis* (pimpernel), blowfly grass and flatweed. The first sighting of arum lily in Bennett Brook is immediately upstream of Mussel Pool.

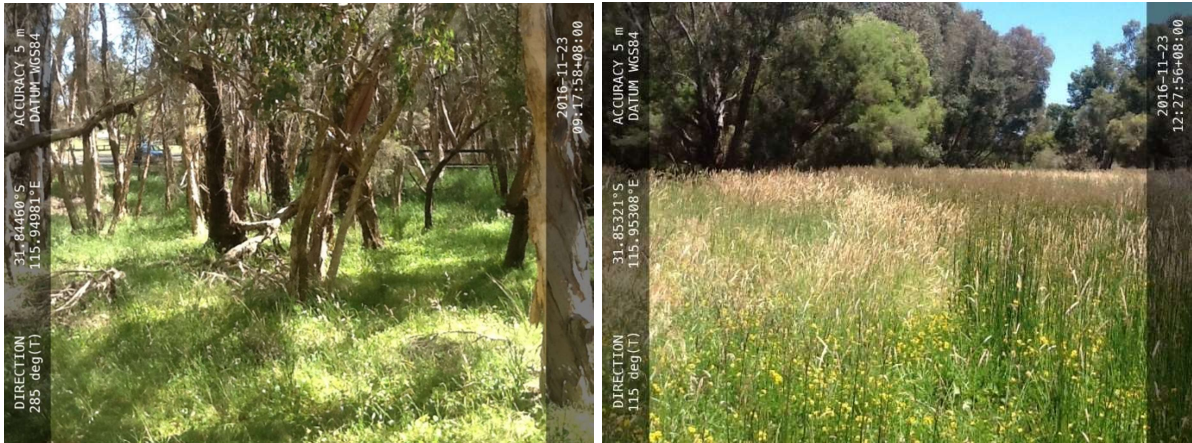
Immediately downstream of Mussel Pool weed cover is extensive (Figure 91-Figure 94). Common weed species include *Ficus carica* (fig), *Juncus microcephalus*, arum lily and annual grasses. Invasive species that first appear in this area are blackberry and Japanese pepper.

Figure 91 (left): Weeds are dominant in the understory downstream of Mussel Pool.
 Figure 92 (right): From Cranleigh St to Marshall Road trefoil, *Juncus microcephalus* and *paspalum* are common.

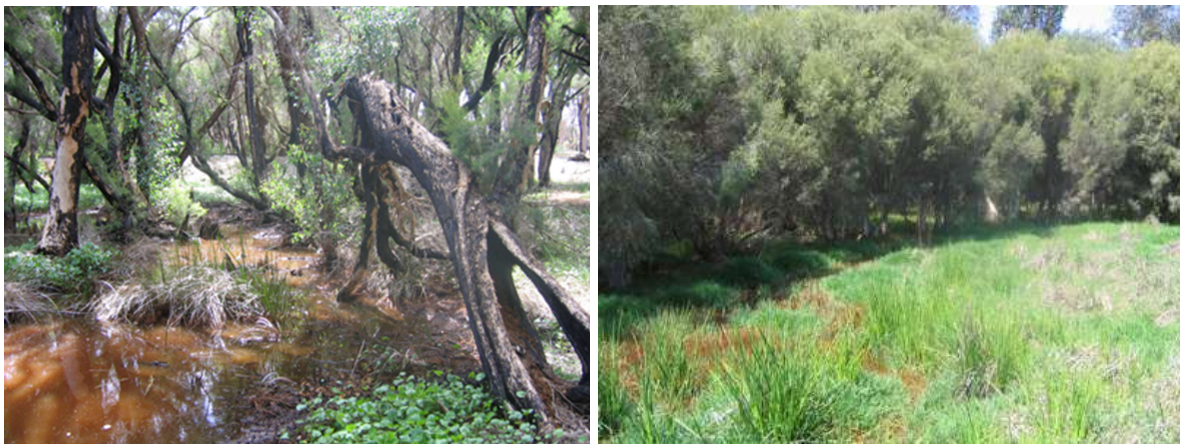
Figure 93 (left): Sedge and *Centella* understory north of Mussel Pool, 2007.
 Figure 94 (right): Similar area to Figure 80 above, in 2007.

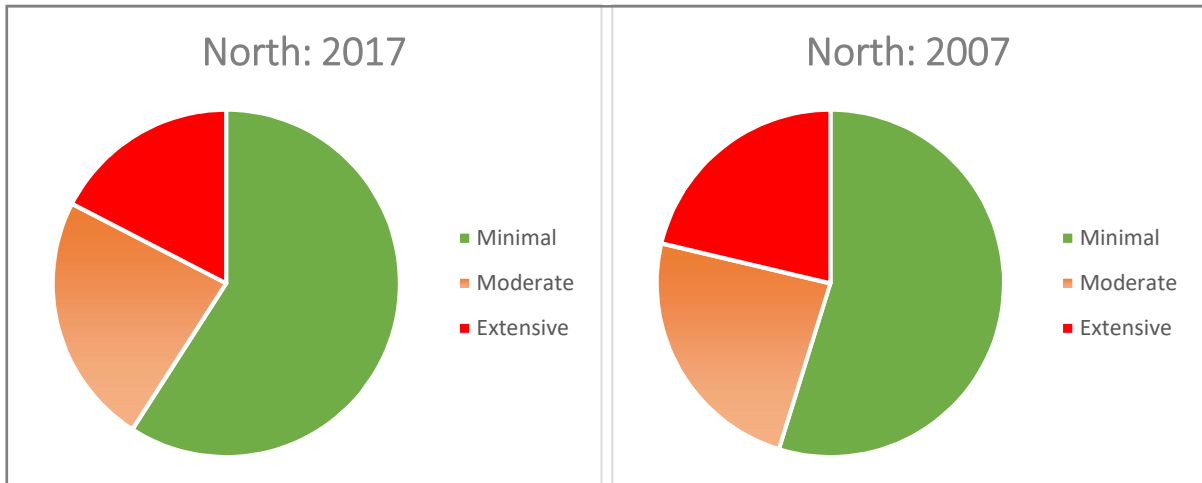
Figure 95: Weed cover ratings for the North section in 2017 (left) and 2007 (right).

In 2007, weed cover ranged from minimal to moderate from the headwaters to Mussel Pool and then was mostly rated extensive (Figure 95). This indicates some improvement in weed cover to 2017. Weed control was not noted in 2007.

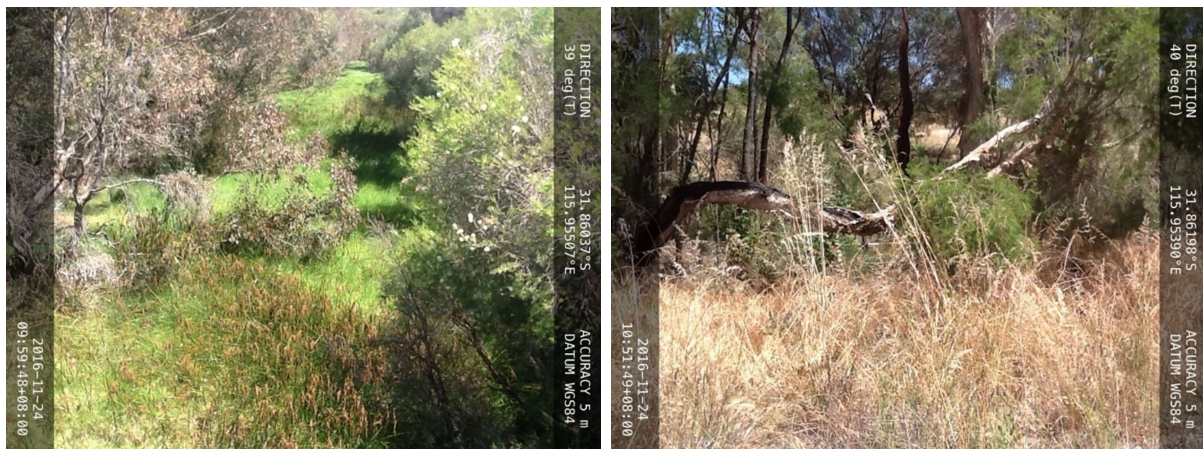
Weed cover is extensive from Marshall Road to Reid Highway, with kikuyu making up the bulk of the understorey (Figure 96, Figure 98, Figure 99). A major weed contributor is a drainage channel from Oriole Park. Invasive species that first appear in the brook at this point include watercress and lantana.

Bandicoot Creek has extensive weed cover due to the prevalence of weedy grasses on the upper banks (Figure 97). These grasses have been sprayed and watercress has been manually removed from the watercourse since the assessment.

Figure 96 (left): Kikuyu is abundant in the understorey north of Reid Highway.

Figure 97 (right): Annual grasses are common on the upper banks adjacent to Bandicoot Creek.

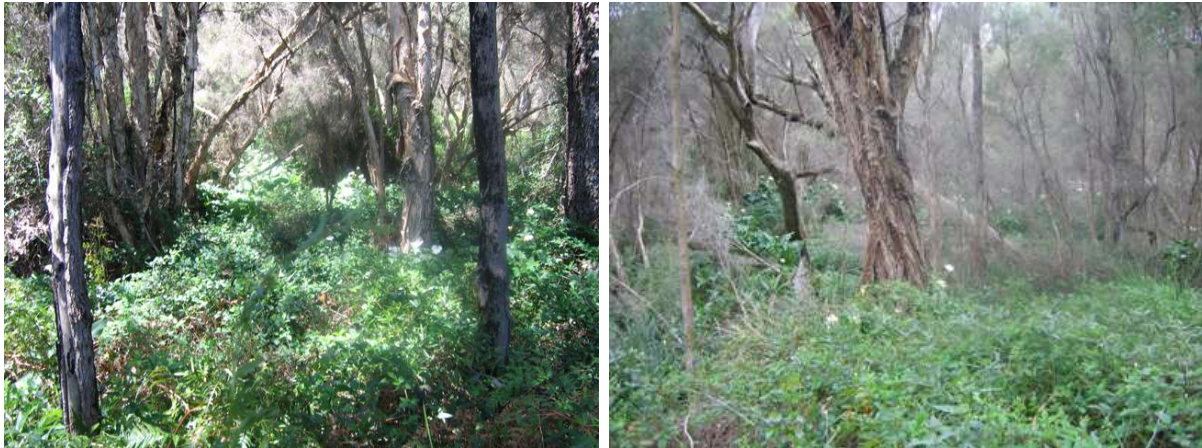
Figure 102 (left): Blackberry infestation near Coonawarra Drain in 2007 which is no longer present.

Figure 103 (right): Arum lily and blackberry infestations near Simla Park in 2007, no longer present.

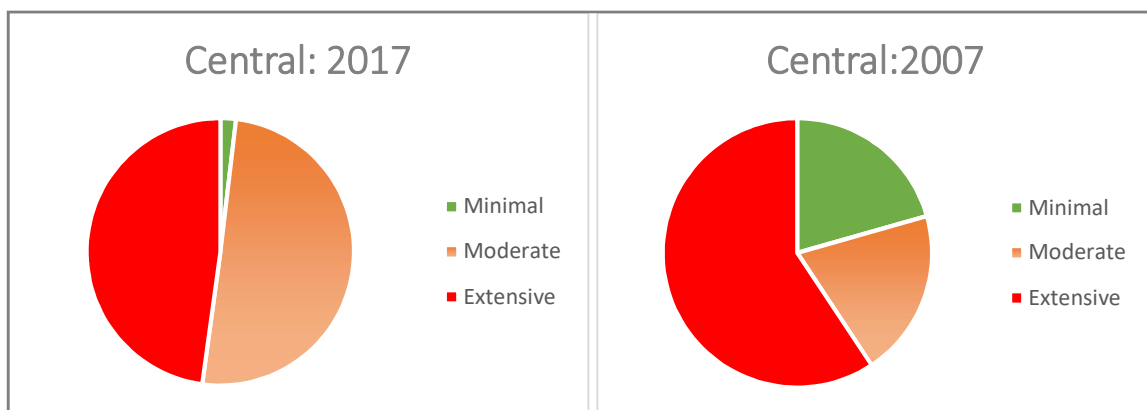
Figure 104: Weed cover ratings for the Central section in 2017 (left) and 2007 (right).

While more of the vegetation had minimal weed cover in 2007 than in 2017, the area of vegetation with extensive weed cover is less in 2017 (Figure 104). It is difficult to make accurate comparisons in the two assessments as it appears that the vegetation condition and weed cover was rated differently to what the 2017 field assessors would have rated it.

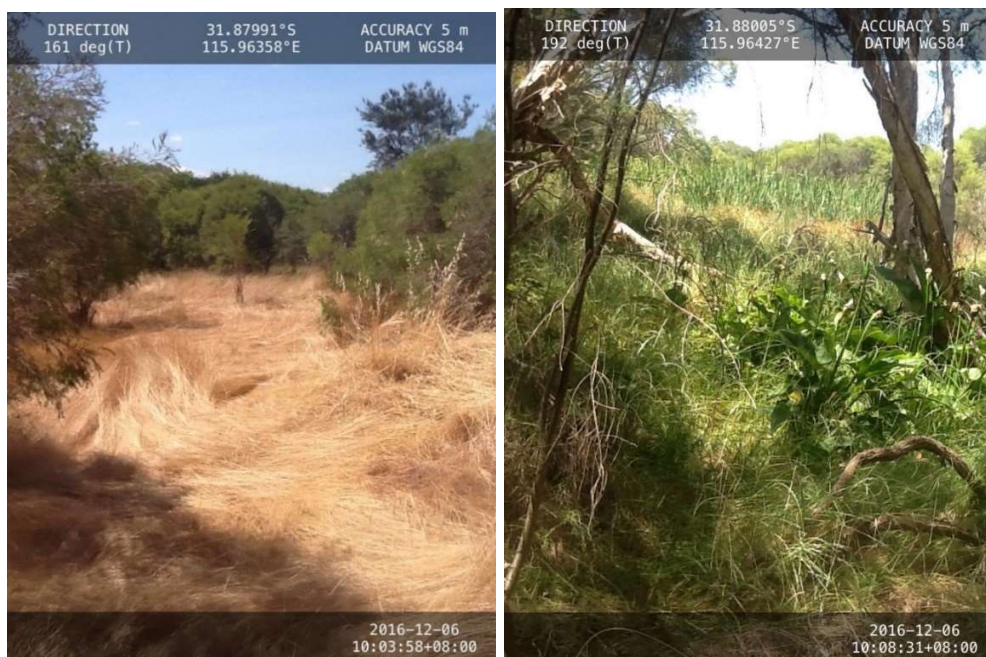
On the eastern side of Grogan Swamp Japanese pepper and arum lily are common. Weedy grasses, particularly *Lolium* sp. and bearded oats, are dominant away from the dense canopy of the main watercourse (Figure 105-Figure 108).

Figure 105 (left): Weedy grasses are common on the eastern side of Grogan Swamp.

Figure 106 (right): Scattered populations of arum lily are common in Grogan Swamp.
