Tributary Foreshore Assessment: Bennett Brook

Conservation and Ecosystem Management Division

March 2019

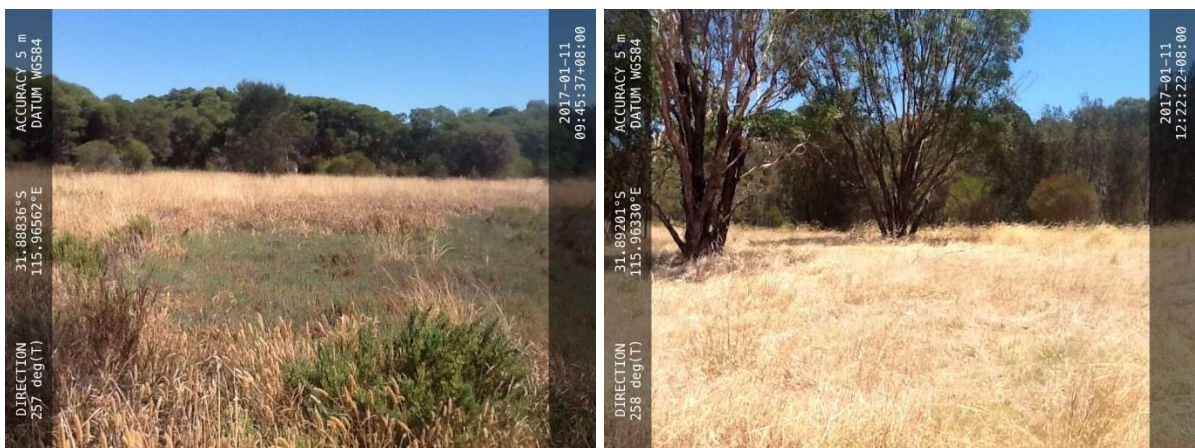
Where samphires are dominant, weeds appear to be limited by salinity and species richness is low. The main weeds are coastal barbgrass (*Polypogon maritimus*) and *Cotula* sp. (Figure 109).

Where the brook reforms as a single channel south of Grogan Swamp, veldt grass, bearded oats and *Lolium* sp. are common on the floodplain (Figure 110). Weeds are partially excluded from the lower banks by dense populations of native *Bolboschoenus caldwellii*.

Figure 109 (left): Coastal barbgrass is common in samphire flats of Grogan Swamp.

Figure 110 (right): Bearded oats and other grassy weeds dominate the upper banks near the confluence with the Swan River.

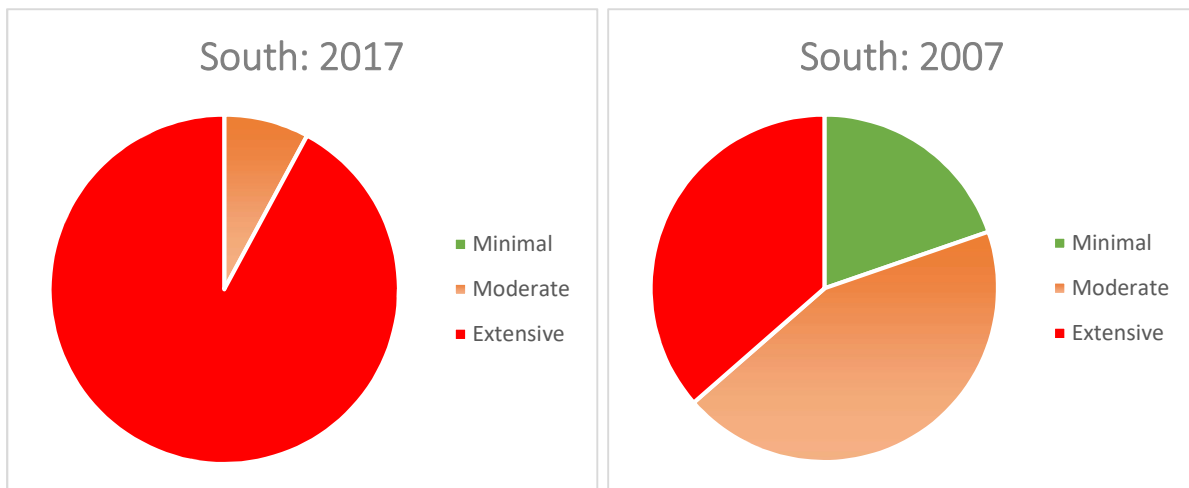
Figure 111: Weed cover ratings for the South section in 2017 (left) and 2007 (right).

There appears to be little improvement in overall weed coverage of the South section from 2007 to 2017 although populations of arum lily have been controlled (*Figure 111*). There has been a reduction in weed coverage in Clarry Small Park on the right bank from extensive to moderate. Segments on the single channel below Grogan Swamp had minimal weed cover in 2007 but the assessment may have concentrated on the lower banks where weed coverage was also found to be less in 2017, rather than including the upper banks as we did in 2017. It is difficult to make accurate comparisons between weed cover from 2007 to 2017 as it appears that the field assessors gave different ratings to what we would have.

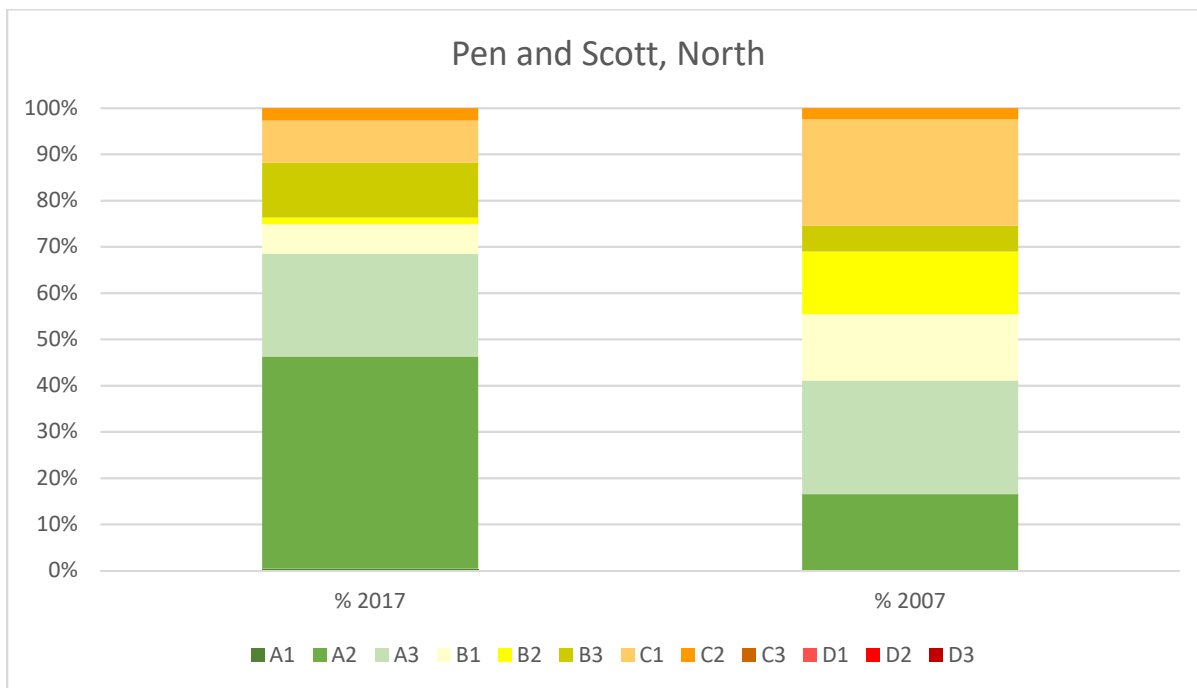
Figure 115: Comparison between Pen and Scott grades for 2017 and 2007 assessments, as a proportion of length of stream bank in the North section.

In 2007 the highest and lowest grades across the section were similar and no segments were in the D grades (Figure 115). Less stream bank was assigned an A grade in 2007. While this may indicate a slight improvement in condition, the subjectivity inherent in the grading system could also account for this.

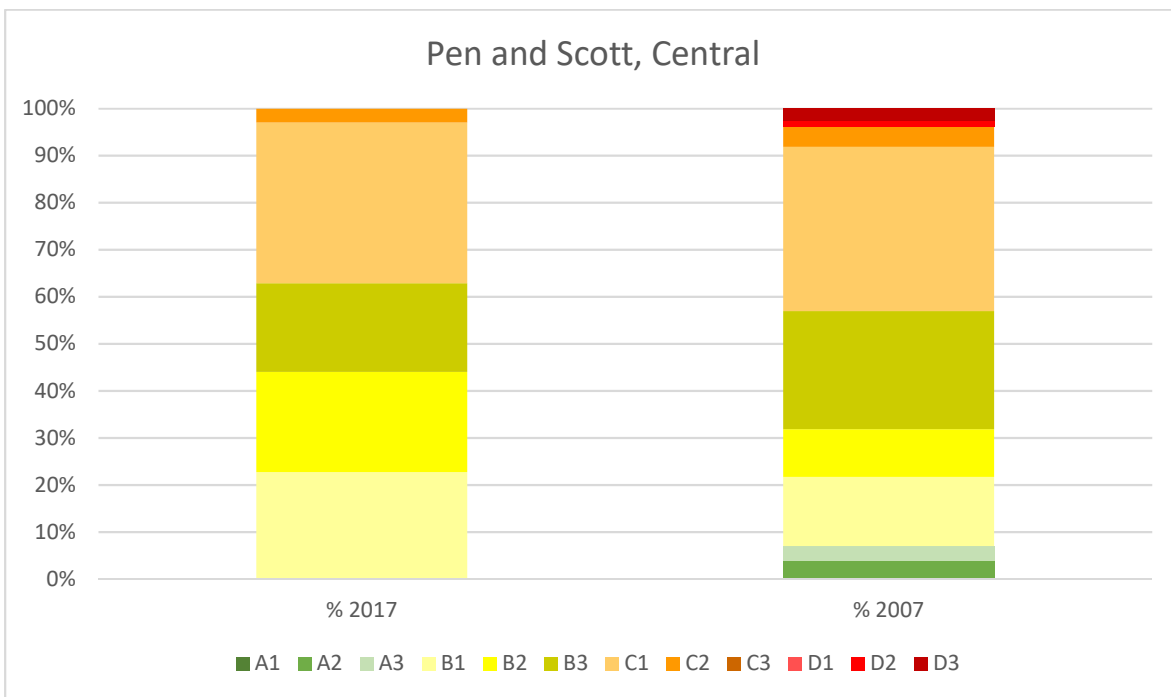
Figure 116: Comparison between Pen and Scott grades for 2017 and 2007 assessments, as a proportion of length of stream bank in the Central section.

No segments are graded in the A grades (Figure 116). The highest grade is B1 and the lowest is C2. Segments are evenly spread across B and C grades.

In 2007 a small amount of stream bank had been assigned A however none was in 2017, as all segments had some level of weed incursion. More stream bank was assigned a B grade in 2017 than in 2007, and a similar amount of stream bank was assigned in a C grade. In 2007 a small amount of stream bank was graded D2 and D3; no segments were assigned D in 2017 (Figure 116).

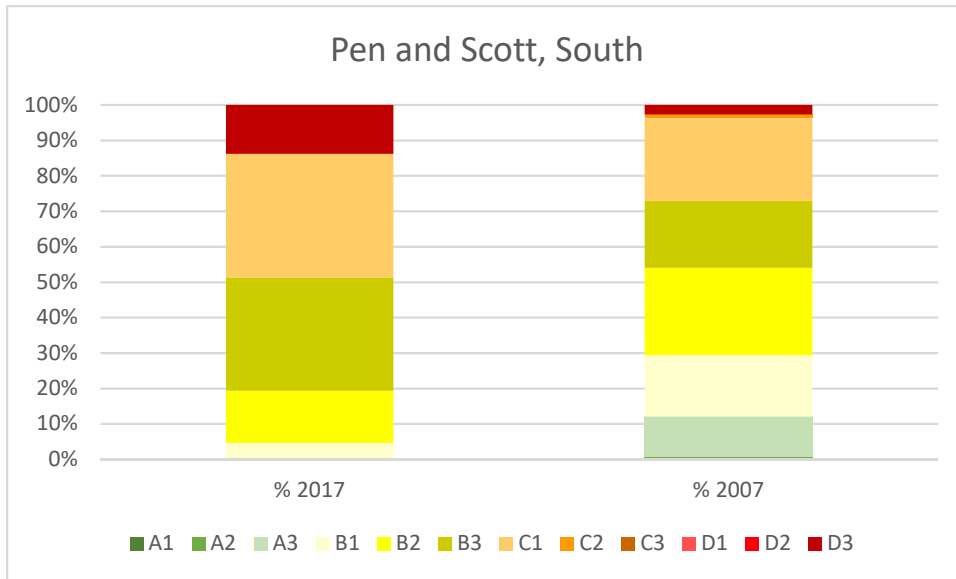
Figure 117: Comparison between Pen and Scott grades for 2017 and 2007 assessments, as a proportion of length of stream bank in the South section.

In 2007 most segments were rated in the B grades, with a small amount of stream bank in the A grades (Figure 117). None of the A grade segments in 2007 were rated A grade in 2017 due to the level of weed coverage. Nearly 50% of stream bank was graded C or D in 2017 while less than 30% was rated C or D in 2007. This indicates a decline in condition though should be considered in the context of subjectivity within the grading system.

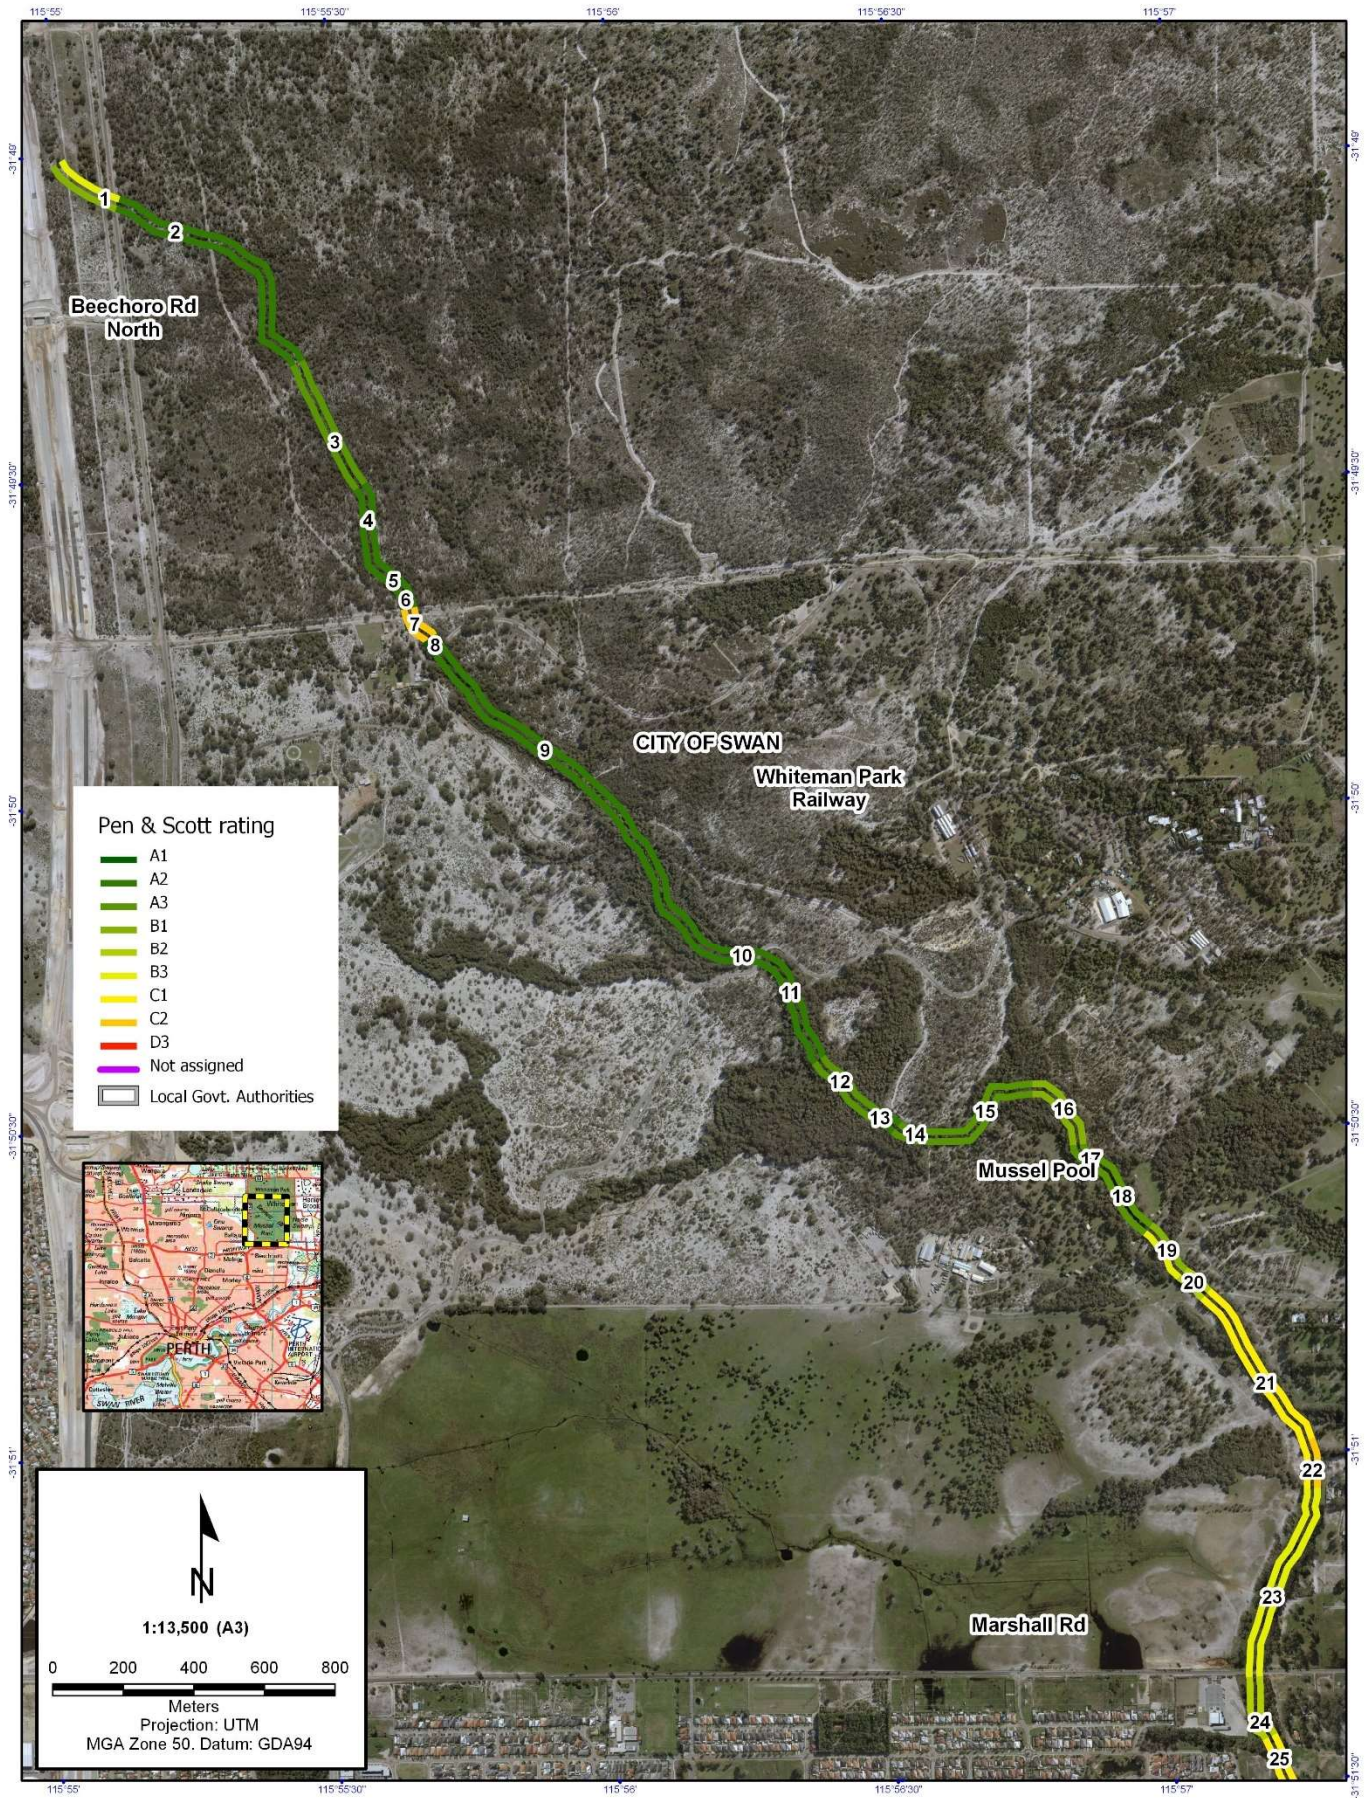
Figure 118: Pen and Scott grading, North section.

The highest Pen and Scott grade is A1 and the lowest is C2 (**Error! Reference source not found.**, Figure 118). Only one short segment scored a grading of A1. This segment is located north of the first Whiteman Park railway crossing.

Five segments are rated in the B (weed infested to weed dominated) grades – these are scattered throughout the section, with one segment at the headwaters, three near Mussel Pool and the other immediately north of Marshall Road.

There are three segments in the C (erosion prone) grade – one contains a sand-based dam in Whiteman Park and is rated C2, and the other two are near private property in Bennett Springs. One is rated C1 where there is extensive weed cover in the understorey. The other segment is rated C2 where stock access the brook and are destabilising the banks, vegetation condition is poor and weed cover is extensive.

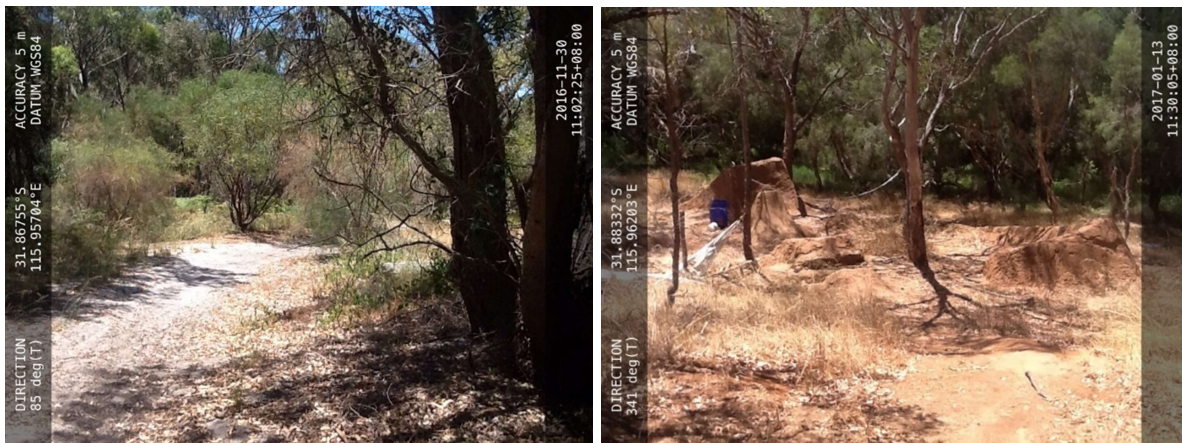
Footpaths along the upper banks and footbridges provide structured walkways in the Central section (*Figure 121*), although off-road driving is evident near Bandicoot Creek and Reid Highway which limits the potential for native plant regeneration.

Most of the South section is fenced and closed to the public on Lord Street and Meadow Street. However, some trail bikes were accessing the floodplain near the Swan Valley Nyungah Community site during the assessment. A jump track has been constructed and there are several make-shift camps nearby (*Figure 122*).

Figure 121 (left): Informal pathways in the Central section.

Figure 122 (right): Bike jump track on the western side of Grogan Swamp.
