## **Remedial Detailed Site Investigation**

### **Wedge and Grey Shack Settlements**

Department of Parks and Wildlife

18 May 2017

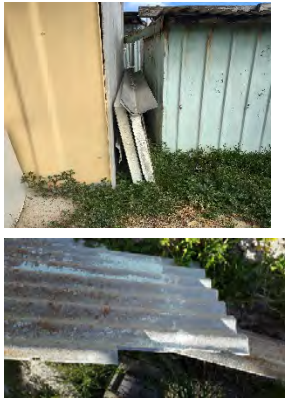
Location Coordinates	Map Number	Shack ID	Description	Approximate Area of Impact	Laboratory Results	Photo
E: 321189.5502 N: 6606610.972	4	116	Five ACM sheets. Also some corner capping noted.	4 m <sup>2</sup>	G4_116_005 Asbestos detected Chrysotile+ Amosite G4_G116_25 Asbestos detected Chrysotile + Amosite

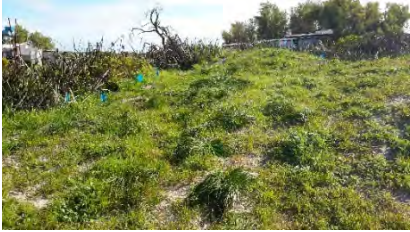
Location Coordinates	Map Number	Shack ID	Description	Approximate Area of Impact	Laboratory Results	Photo
E: 327331.4675 N: 6588939.6505	2	52	Mound ACM buried in dune. Appear to be remains of a structure pushed into dune.	80 m <sup>2</sup>	Not sampled

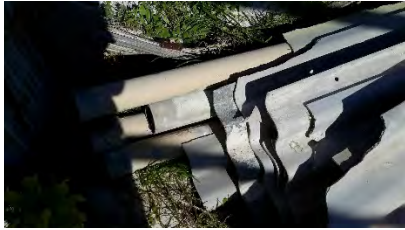
E: 326963.4166 N: 6589163.7644	9	110	Sheeting ACM sheeting	10 m <sup>2</sup>	W9_W110_005 Asbestos detected Chrysotile + Amosite + Crocidolite

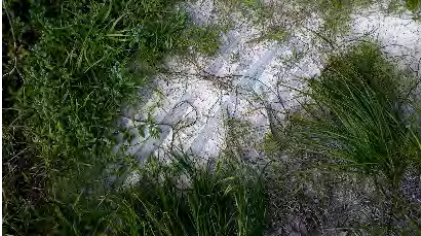
Location Coordinates	Map Number	Shack ID	Description	Approximate Area of Impact	Laboratory Results	Photo
E: 326948.1722 N: 6589650.0957	15	142	Sheeting ACM sheet partially buried in dune west of shack.	3 m <sup>2</sup>	Not sampled

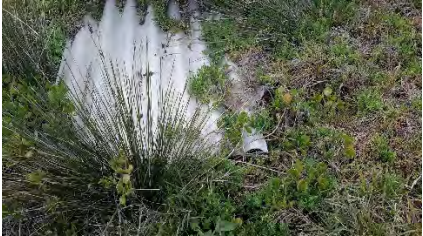
E: 327396.337 N: 6589345.9509	8	288	Sheeting ACM sheet partially buried.	2 m <sup>2</sup>	W8_W288_014 Asbestos detected Chrysotile + Amosite

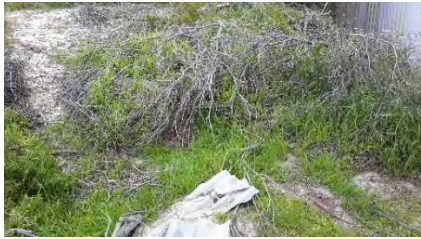
E: 327272.7108 N: 6589365.3215	8	Common Area	Sheeting ACM sheeting partially buried in mound.	30 m <sup>2</sup> x 2 m high	W8_Common Area_20 Asbestos detected Chrysotile + Amosite

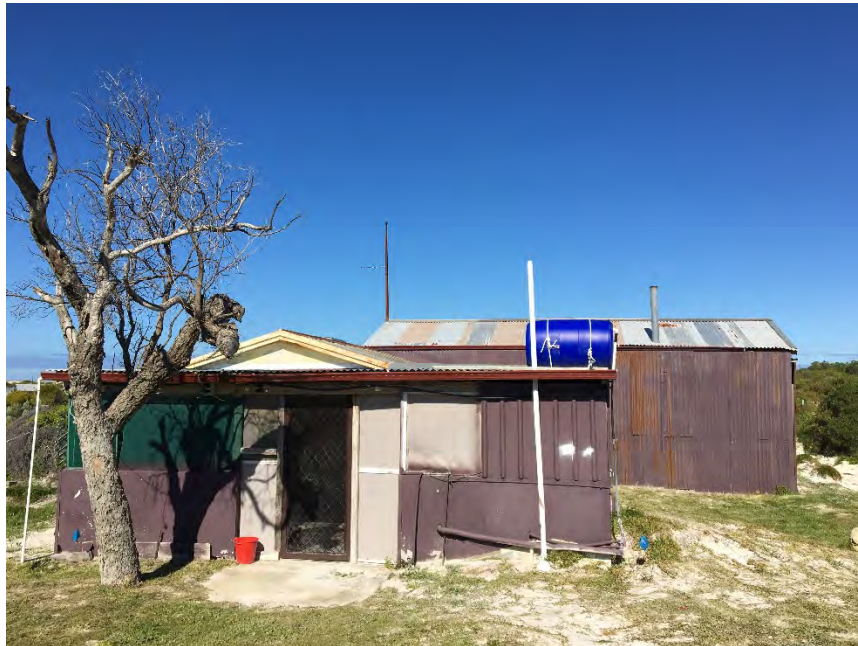
**Photo 1. Wedge shack W99, AF sampling conducted along back wall of shack (not visible).**

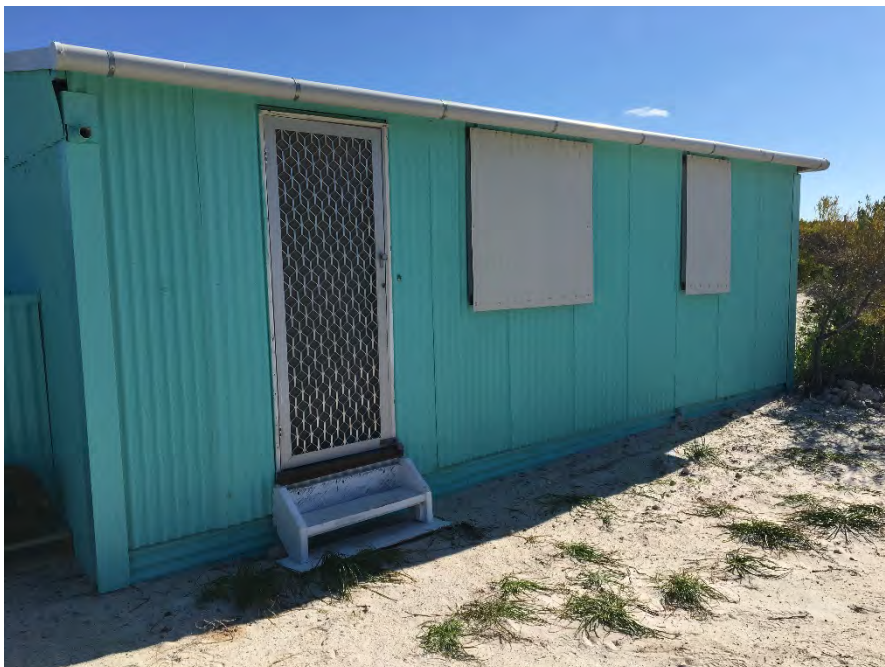
**Photo 2. Wedge shack 162, AF samples were collected adjacent to the shack wall and stepped out.**

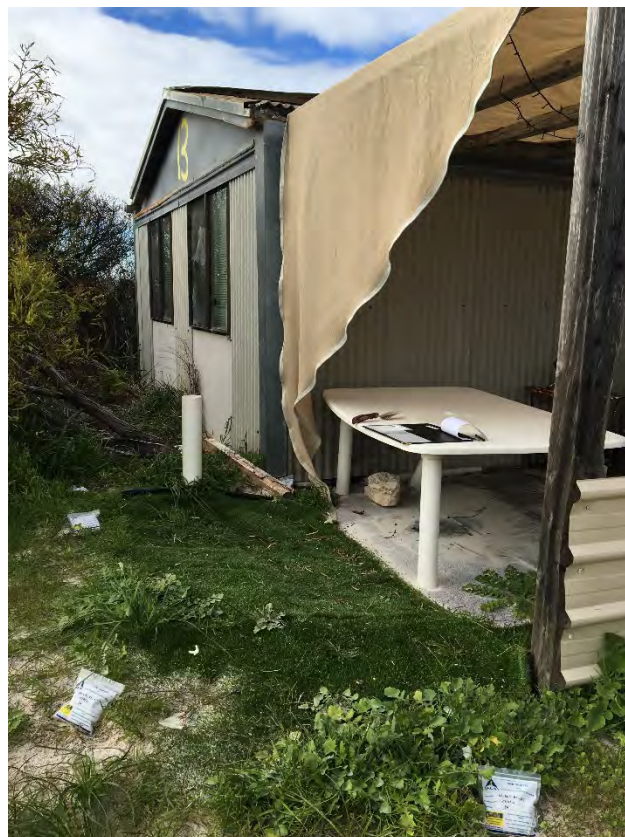
Samples were collected from the north-eastern side of W013 as this was the only side of the shack that could be accessed which contained bare soils where possible runoff from the ACM roof was evident. Evidence of runoff from the roof (drip lines) were identified on this side of the shack. Sampling locations for W013 are shown on Plate 4 (**Appendix I**).

**Photo 4. AF sampling at Wedge shack W13**

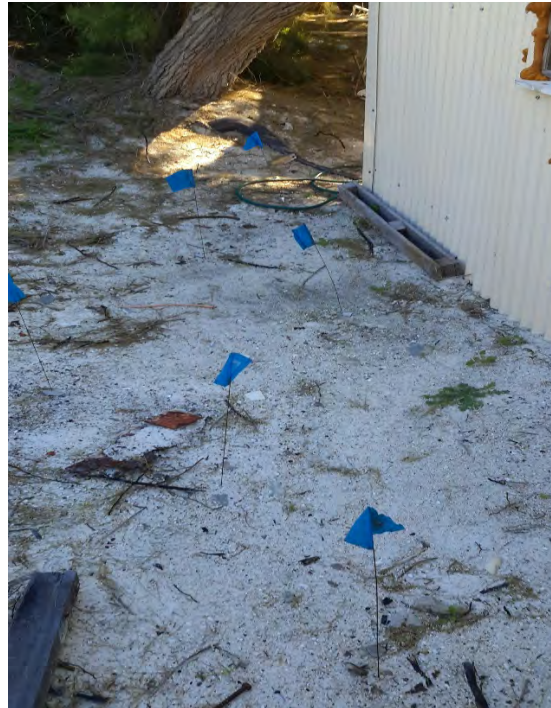
**Photo 13. Occurrence of suspect ACM at W18**

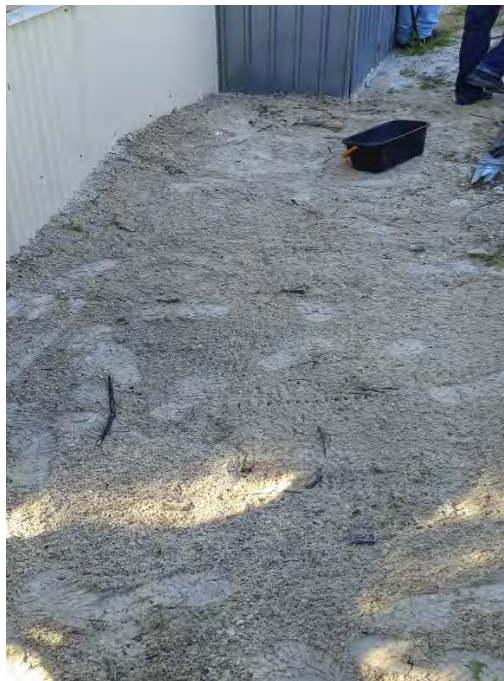
**Photo 14. Same occurrence at W18 remediated and 'resolved'.**

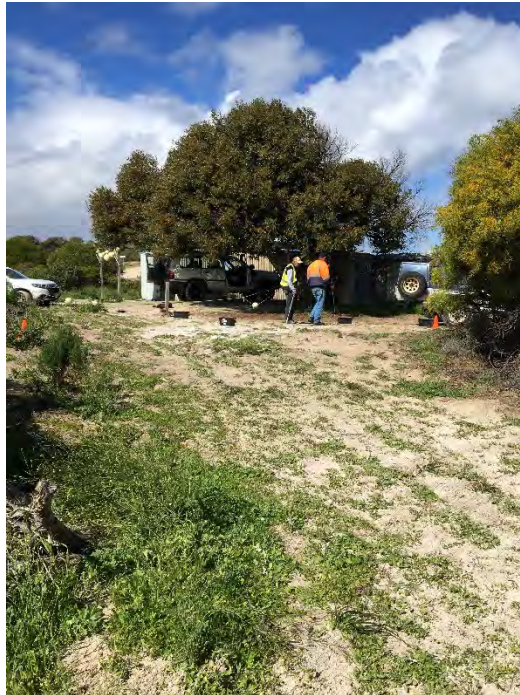
**Photo 17.: Remediation of scattered suspect ACM fragments at G63.**

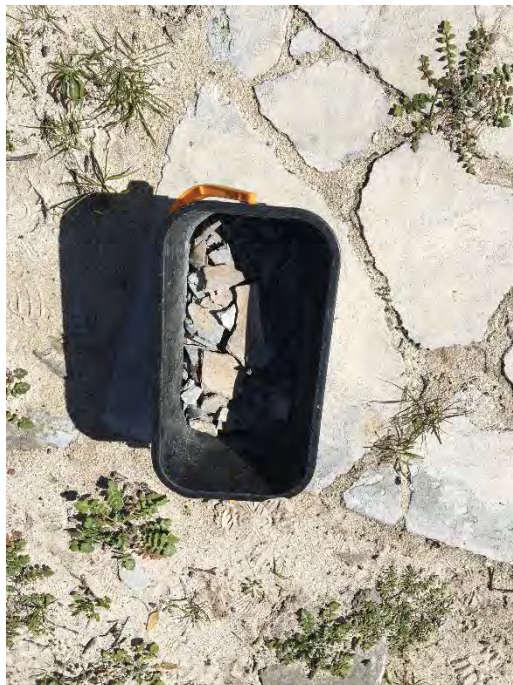
**Photo 18. Suspect ACM fragments collected at G63.**

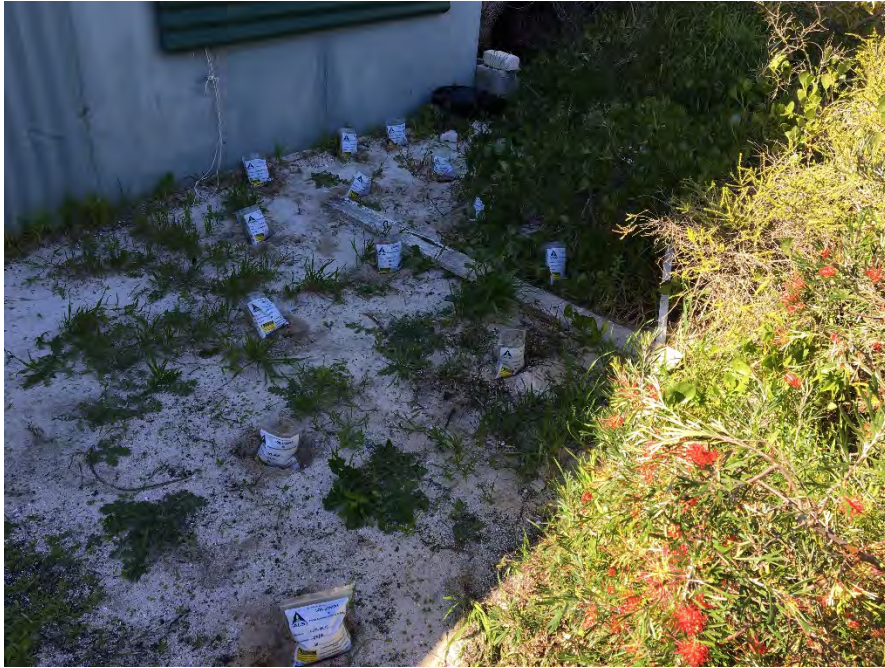
Samples were collected from the western side of G009 due to access restrictions on all other sides of the shack. Sampling locations for G009 are shown on Plate 23 (**Appendix I**).

**Photo 23. AF sampling at Grey shack G09.**

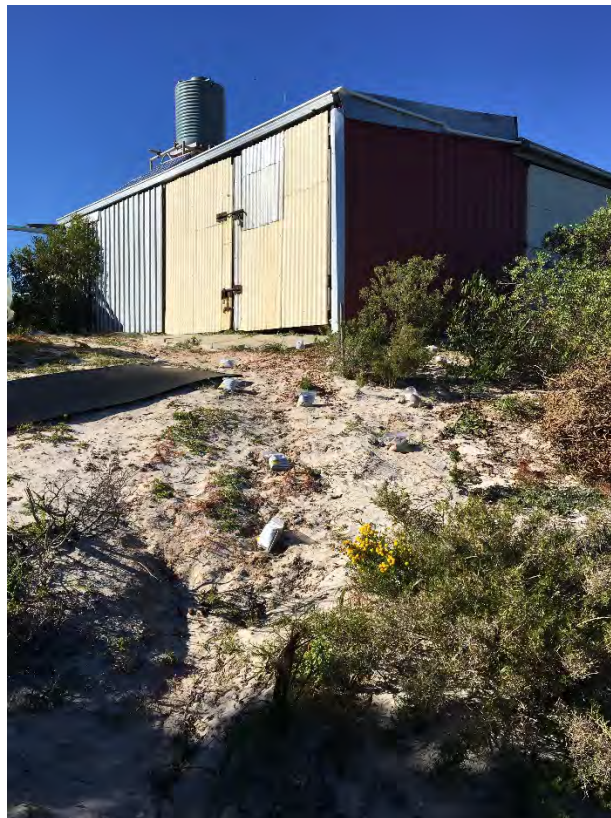
Samples were collected from the northern and eastern sides of W170 and the north-western side of G067. Samples were targeted towards locations of driplines and runoff from these shacks (Plate 3 and Plate 24, **Appendix I**).

**Photo 24. AF sampling at Grey shack G67**

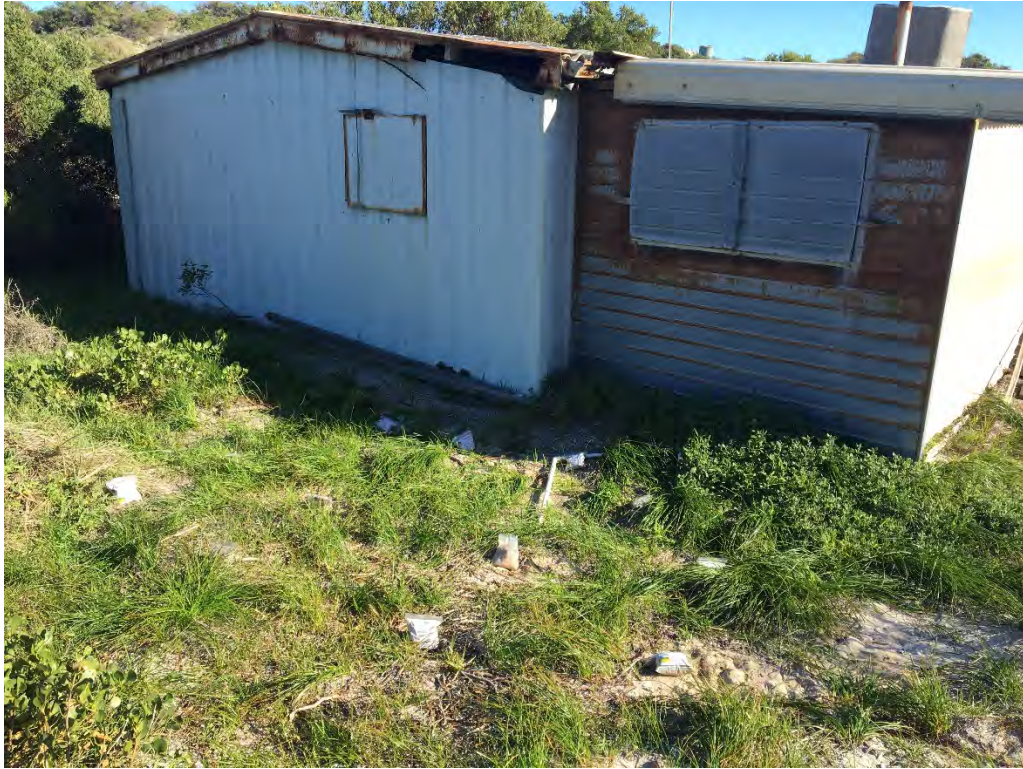
**Photo 25. AF sampling at Grey shack G92.**
